969 Burrard Street & 1019-1045 Nelson Street
STATEMENTS OF SIGNIFICANCE AND CHURCH CONSERVATION PLAN

1021-1023 NELSON STREET
STATEMENT OF SIGNIFICANCE
DECEMBER 2014

DONALD LUXTON
AND ASSOCIATES INC

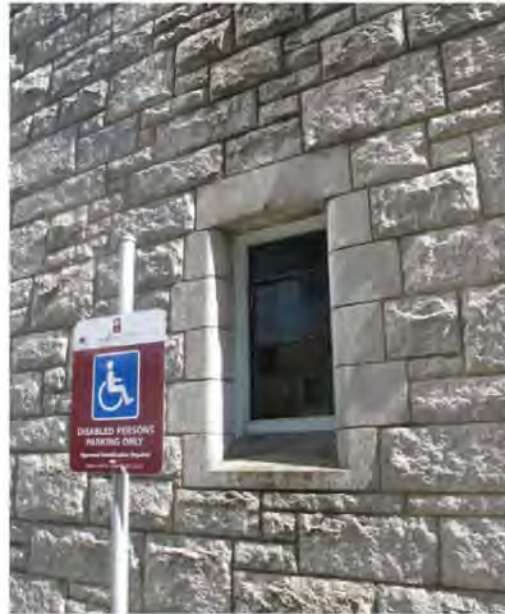
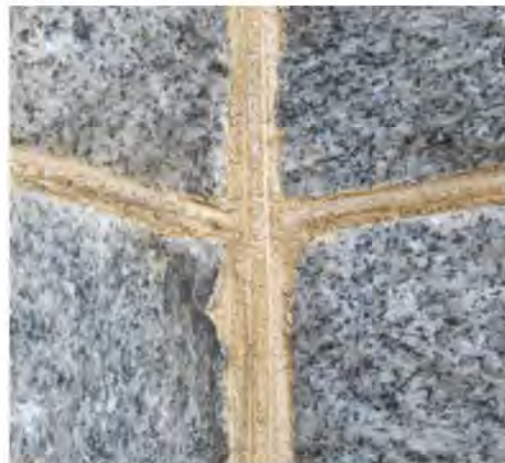
Top: Smooth-dressed granite blocks
Bottom: Close-up of mortar

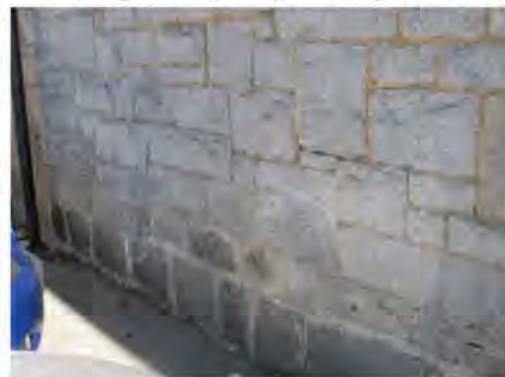
During the site review deteriorated joints were observed in few locations, particularly near the pavement where water back splash occurs. Here mortar was either porous or missing. Previous joint repairs above grade were

Left and centre: Examples of historic composite walls (www.buildingconservation.com); Right: Sandstone blocks at foundation

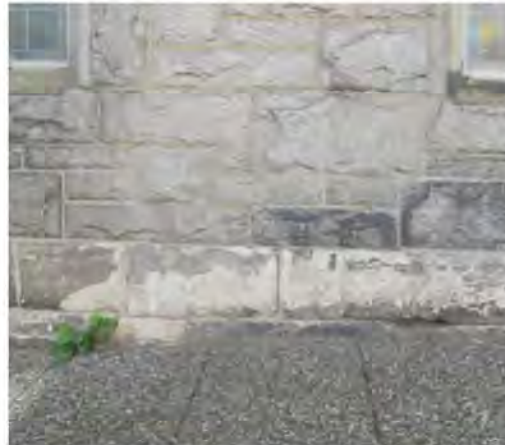
Above grade vegetation and damaged sandstone growth

The exterior sandstone blocks are important character-defining elements of the First Baptist Church and will be retained. A close-up condition survey should be undertaken and, where required, restoration work will be carried out in accordance with national conservation guidelines.

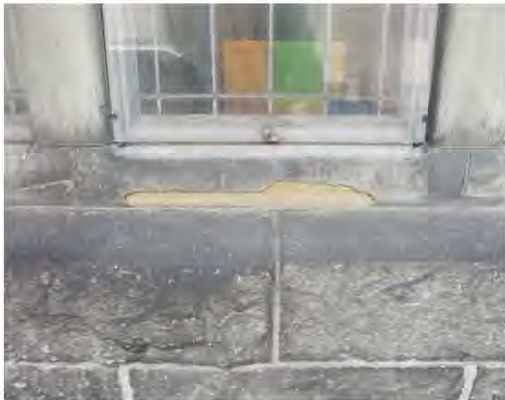
Weathered sandstone

Signs of weathering are evident on the east window surrounds of Pinder Hall, and previous repair attempts were carried out. The most visible damage occurred at the sandstone foundation walls above grade with granite blocks rising above the sandstone. Delamination of sandstone is evident and a result of frost action while winter salt is a contributing factor. Mortar joints are also affected by weathering and environmental dirt accumulated on the surface of sandstone material and mortar joints, darkening the original buff colour.

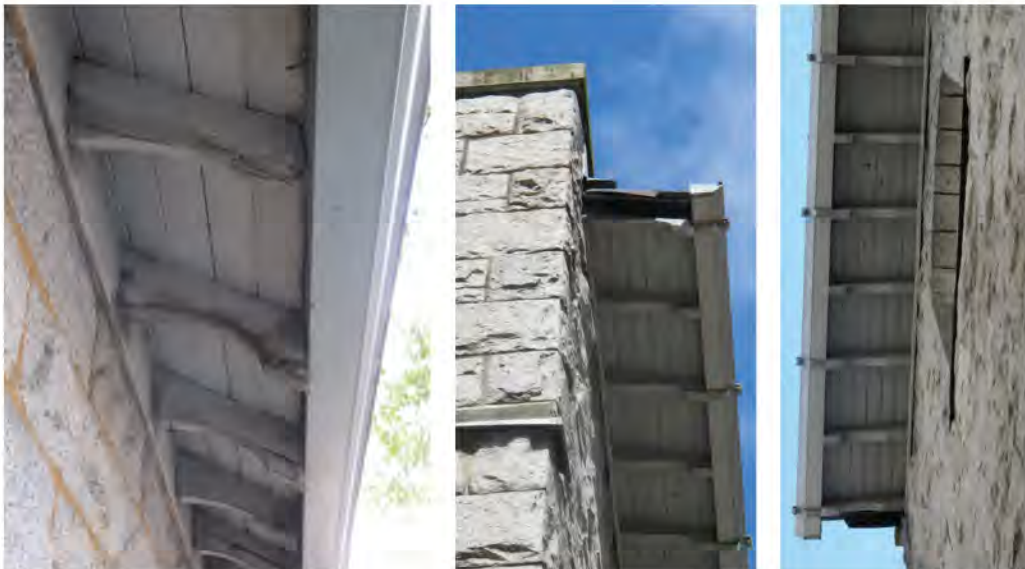
Modern gutters and downspouts take care of proper rainwater drainage and notable damage was only observed in few locations viewed from the ground. Moisture damage occurred for example on the north-facing clerestory wall of Pinder Hall where downspouts may leak and paint is flaking from the stuccoed wall.
