COUNCIL REPORT

TO: Vancouver City Council
FROM: City Building Inspector
SUBJECT: Declaration of Dangerous Building at 500 Dunsmuir Street, Vancouver

500 Dunsmuir Street, Vancouver, BC – Building Structural Assessment

aDB No. 240674

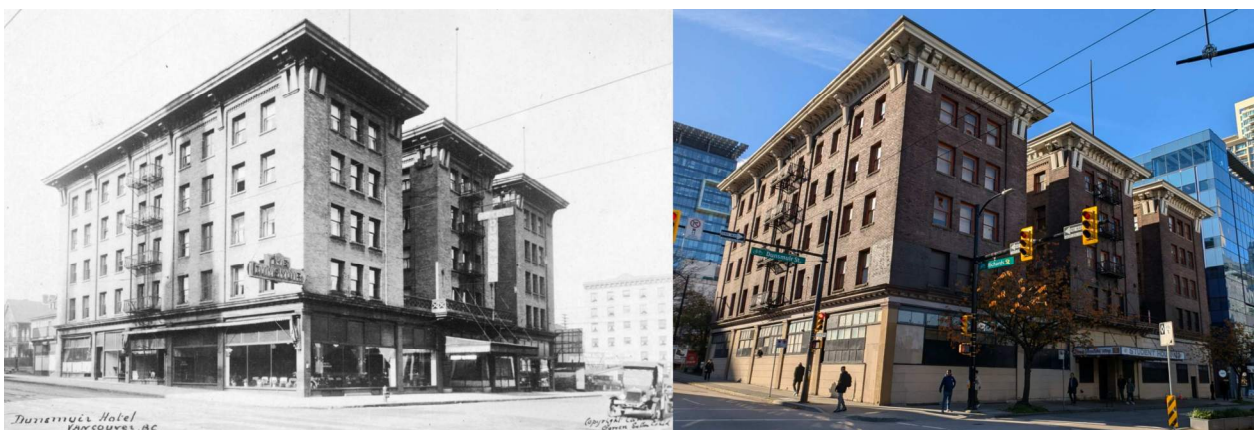
Figure 1, Original building circa 1910, photo left. Building at time of this report, photo right.

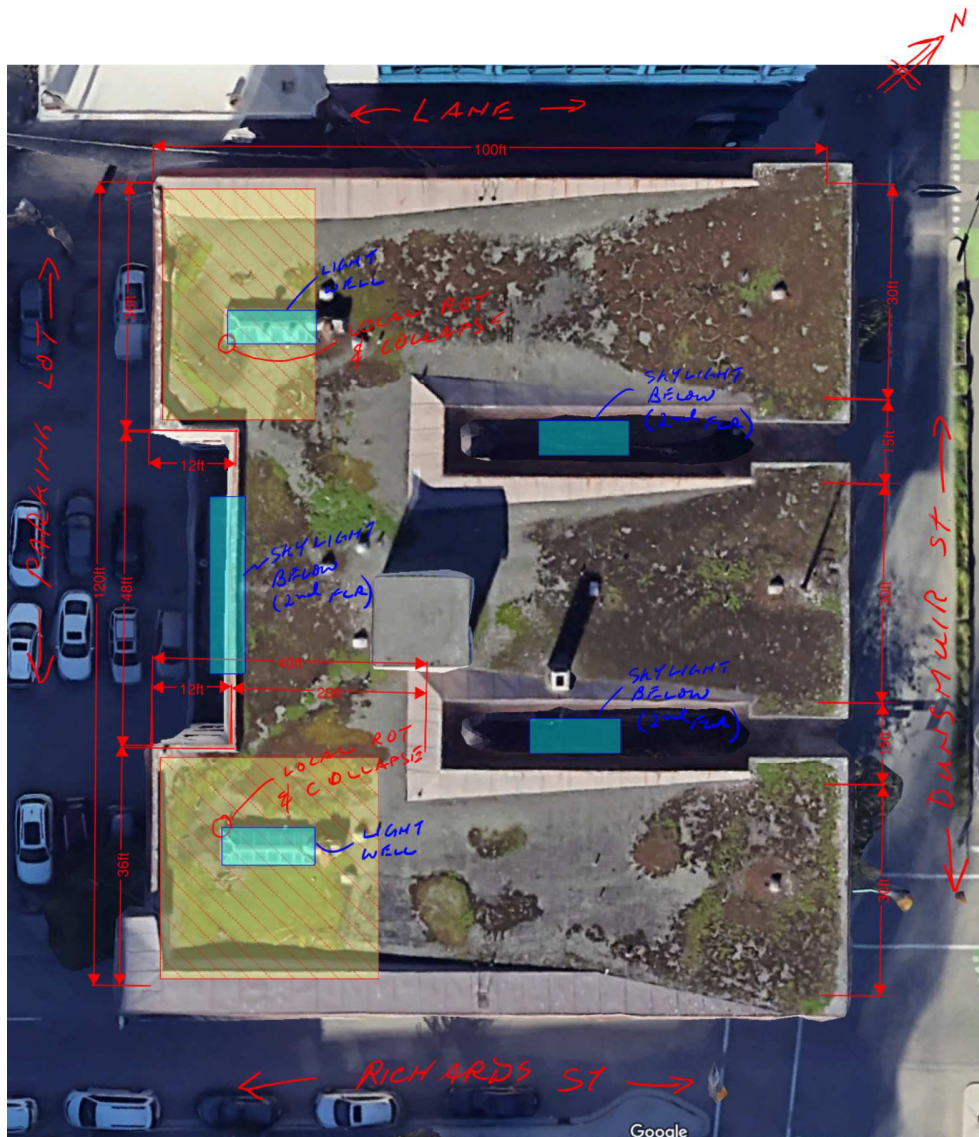
Figure 2, Site plan with estimated measurements shown and building elements for reference, N.T.S.

The southeast corner of the building is structurally compromised in its ability to carry the self-weight of the floors, the roof loads (both ponding and/or snow loads) and any imposed floor live loads (see Figure 2, area highlighted yellow, southeast corner). These multiple floor levels are currently supported by a single steel beam at the 2nd floor spanning 25ft with a tributary area of 450 sqf per floor. The condition of the steel beam is unknown so the probability of failure for this steel beam cannot be determined at this time. However, considering the extent of rot and mold in this area, the integrity of the steel beam should not be overestimated and must be considered insufficient to carry the code prescribed loads. There is also a second mode of failure in this area being the collapse of the laminated 2x solid wood floors and/or the supporting 2x stud walls. Failure of any one of these elements or combinations thereof would result in a cascading collapse scenario, as it is unlikely that any one floor would have the capacity to support the impact forces from a floor above. It is further postulated that the progressive collapse of any floor and the resulting impact forces could also compromise the steel beam resulting in the complete loss of all floors and roof in this corner of the building.

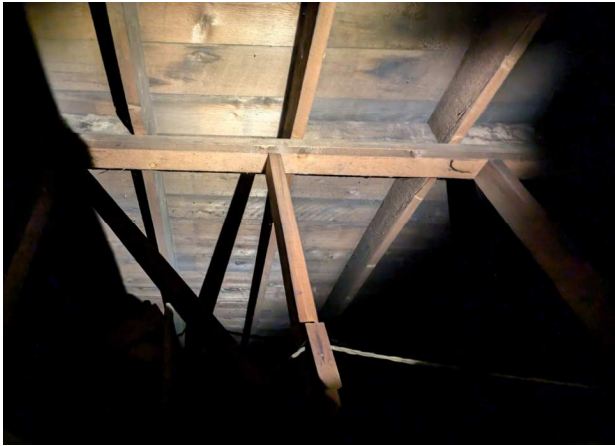
The roof is comprised of built-up timber-framed construction with 2x roof rafters on 2x pony walls (Figure 3) creating a roof slope running from the Dunsmuir Street side (north) down to the parking lot at the rear (south) of the building. The roof had significant moss coverage (Figure 4) and visible water ponding at each of the two skylights (Figures 5 and 6) at the south side of the building. The entire roof coverage would appear to have only two points of drainage for removal of precipitation with each drain located adjacent to each of the two skylights.

Figure 3, Roof rafters on pony walls.

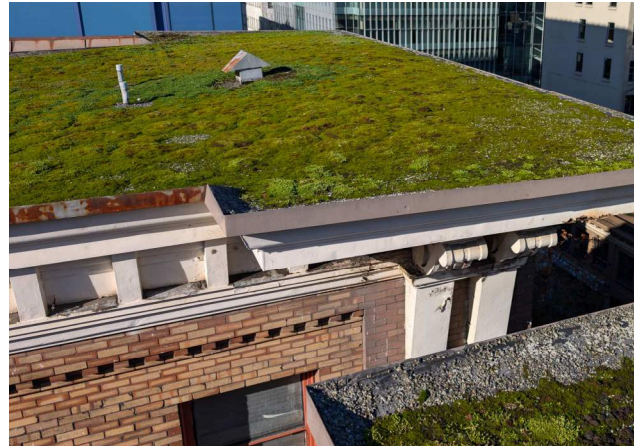
Figure 4, Roof with moss growth and cornice.

The perimeter of the roof has a substantial overhang with an architectural detailed cornice made of sheet metal. Due to the unknown and questionable condition of the roof, the cornice could not be accessed for closer inspection. There are areas of rust visible on various locations of the cornice. This rust may indicate water ingress that could have effects on the supporting structure of the cornice and/or the integrity of the cornice. Further investigation would be recommended to verify the condition and supporting structure of the cornice.

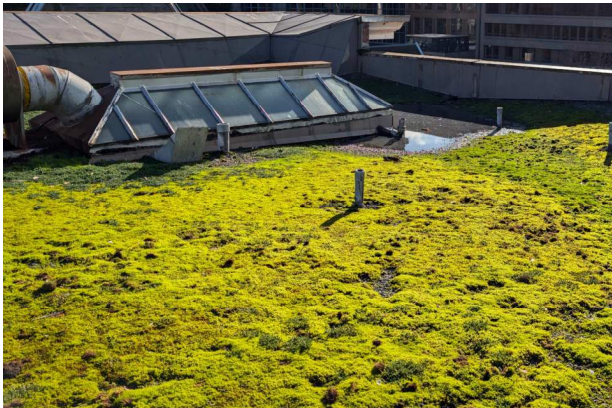
Figure 5, Southeast skylight with water ponding.

The roof at each of the two skylight locations is visibly lower than the drainage scuppers preventing the area from fully draining and thus allowing ponding (the accumulation of water) locally in these areas. This water ponding can create significant structural issues for the supporting timber assembly due to the added weight of the accumulating water.

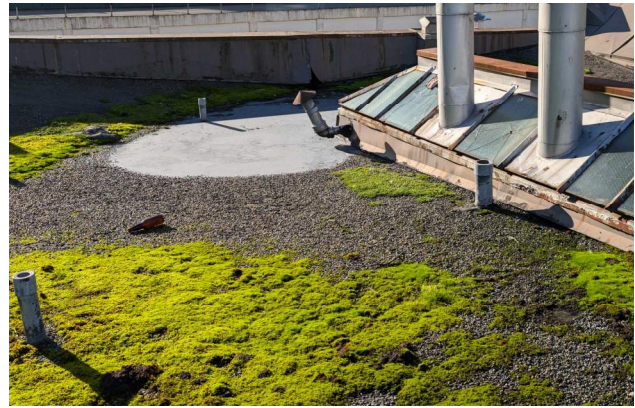
Figure 6, Southwest skylight with water ponding.

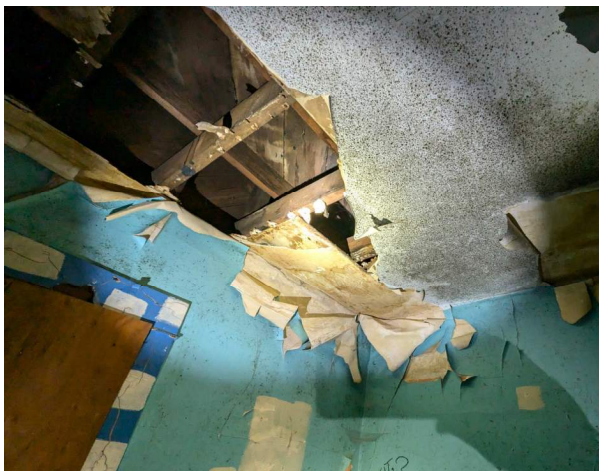
The top floor ceiling had significant ceiling damage from water ingress. The amount of water damage varied from the front of the building (north) towards the back with the most pronounced damage at the back (south) of the building where the two roof skylights were located (Figures 7 through 10).

Figure 7, Top floor ceiling, north end hallway.

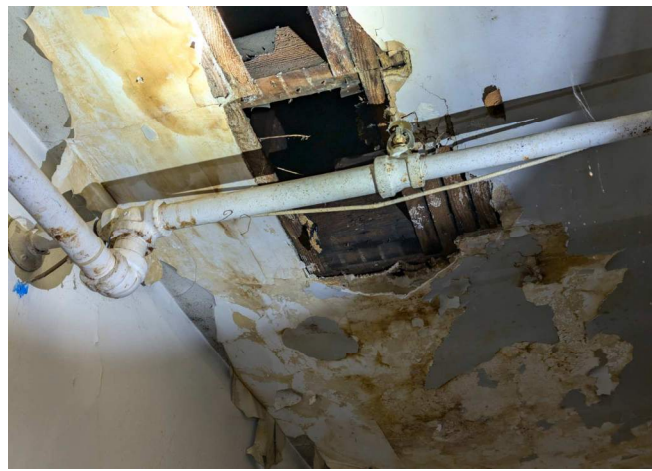
Figure 8, Top floor ceiling, north end hallway.

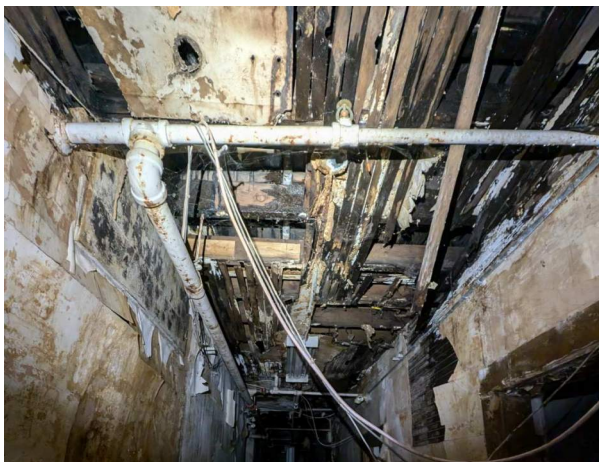
Figure 9, Top floor ceiling, south end hallway.

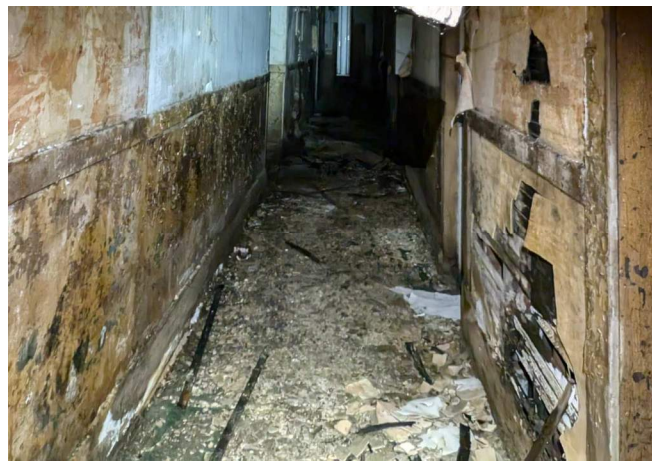
Figure 10, Top floor hallway, south end hallway.

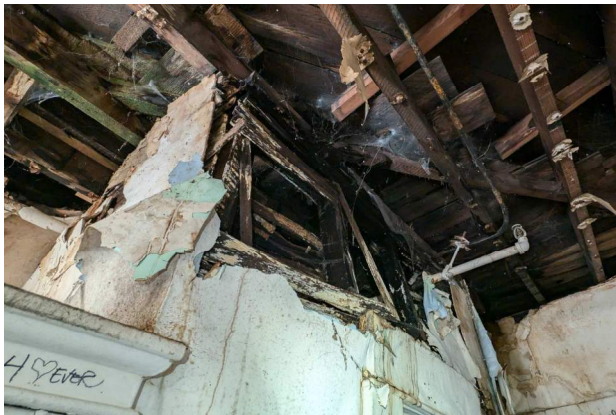
The most extensive areas of water ingress and material saturation were found around the two skylights. In these areas, the ceilings had locally collapsed, and the exposed roof timbers had been structurally compromised because of rot. Also found in these areas, the stud walls were rotten and had buckled under the weight of the roof and in some locations punched through into the rotten floor below (Figures below).

Figure 11, Buckled rotten wall under roof.

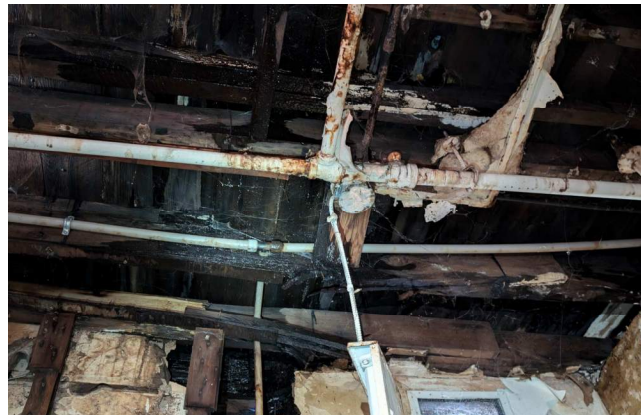
Figure 12, Failed roof rafter due to rot.

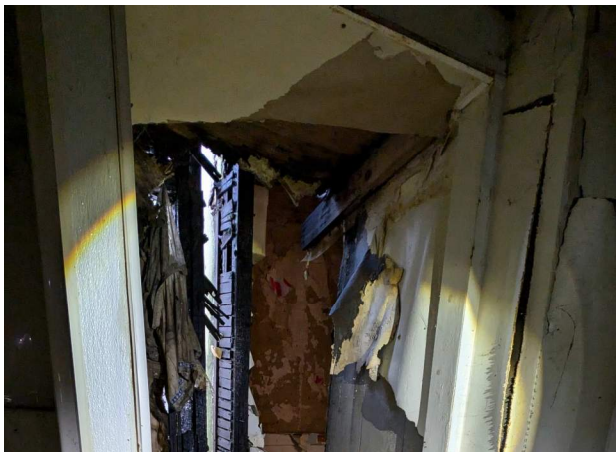
Figure 13, Ceiling/roof with broken rafter visible.

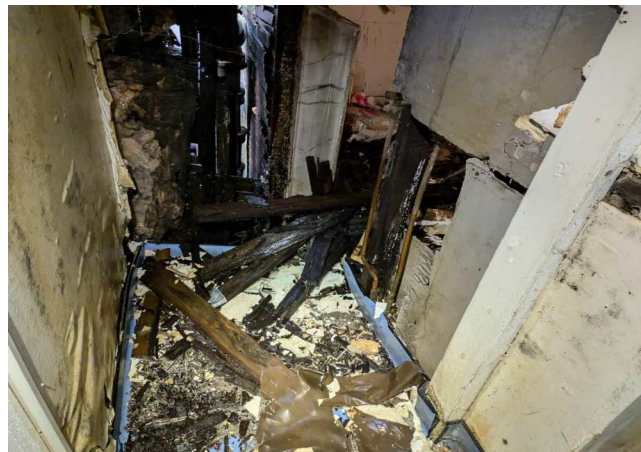
Figure 14, Collapsed ceiling/roof members onto floor.

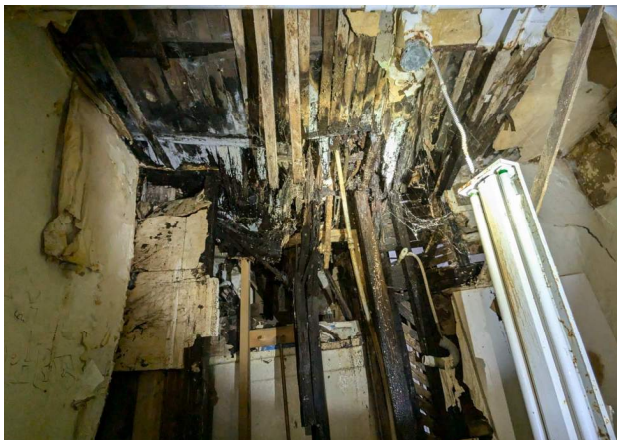
It was noted that these floor levels are built differently from the roof. The floors of these levels are comprised of parallel laminations of 2x members creating a solid timber floor supported by load-bearing 2x stud walls. This type of floor construction is visible in photos 15 through 18 with similar degrees of rot, saturation, floor collapse and wall failures as seen from the underside of the roof.

Figure 15, Structural collapse of floor and failed supporting wall due to rot at 4th floor.

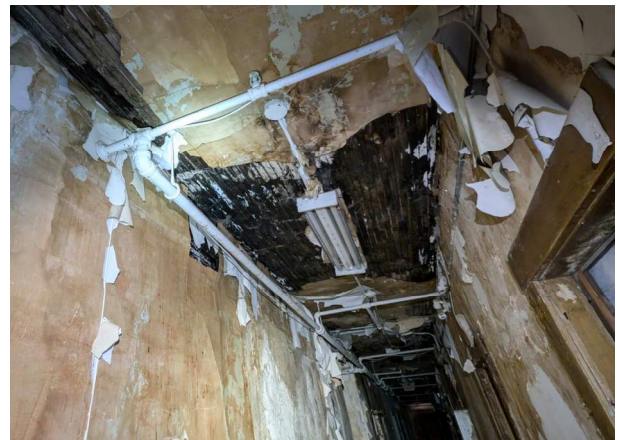
Figure 16, Saturated ceiling and floor system.

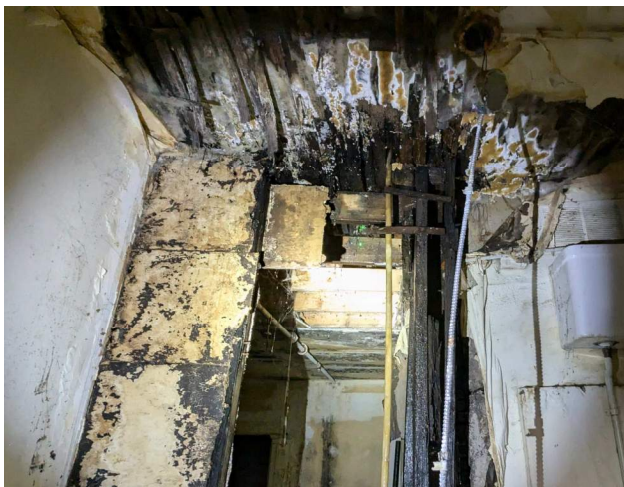
Figure 17, Structural collapse of floor and failed supporting wall due to rot at 3rd floor.

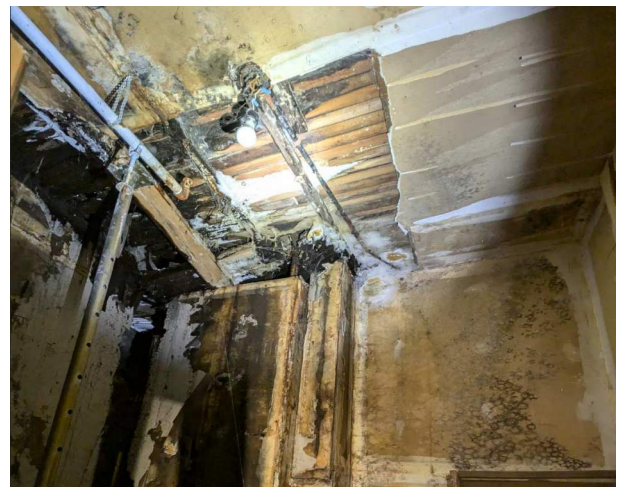
Figure 18, Previously installed steel shoring post to support rotten collapsing floor.

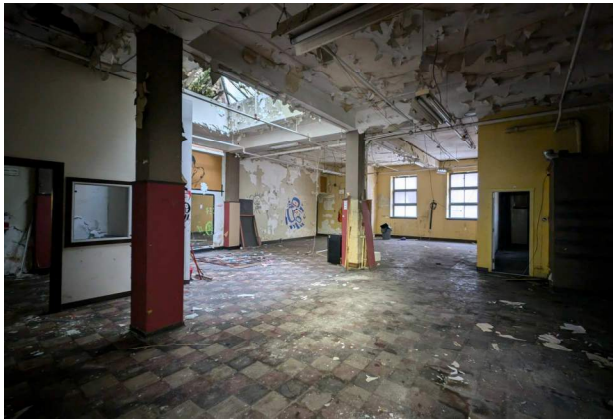
The main floor is comprised of large open spaces (Figure 19) requiring the second floor to be a structural transfer level supporting the upper floors (i.e., the upper load bearing stud walls do not continue to the main floor but are terminated at the 2nd floor). This transfer system is made up of a laminated 2x solid floor, likely 8” thick, supported by beams which in turn are supported by columns. These beam and column lines would also support all the multi-wythe brick walls including the exterior brick walls of the three building wings (the brick walls at the lane and the rear parking area are the only brick walls that are directly supported by the basement foundations walls).

Figure 19, Example of open areas on main floor.

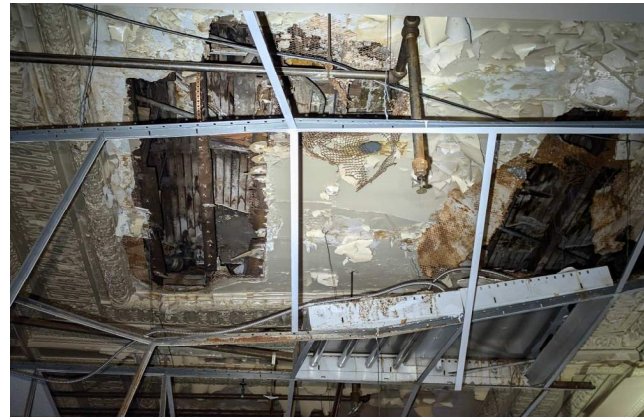
Figure 20, Main floor ceiling water ingress.

Like the upper floors and roof, this floor level has extensive water damage and rot (Figure 20). Ceiling debris is observed throughout this floor level and large ceiling openings exposing the floor structure are evident where the saturated ceiling has fallen away.

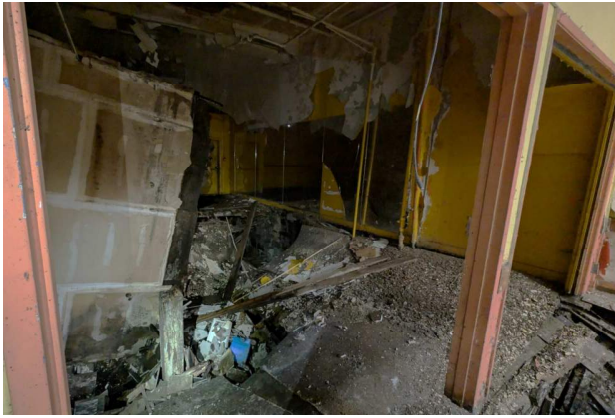
The most significant area of structural damage is in the vicinities under the skylights at the back of the building. The floor at the southeast corner is severely compromised with a substantial portion having fully collapsed into the basement (Figures 21 through 24). The ceiling directly over this area is saturated and was also actively dripping water at the time of our inspection. The collapsed areas have significant damage to the structural members with some larger timber beams and columns completely severed due to the extent of rot. This location aligns with the most severely degraded and structurally compromised areas on the floors above. It is evident that the steel beam spanning over this collapsed area is under significant load due to the saturated materials above and further stressed during periods of precipitation when the weight from ponding is applied. The condition of these steel beams is unknown as they were concealed in wooden laths and remnants of plaster. Further assessment of these steel beams is recommended.

Figure 21, Complete floor structural collapse.

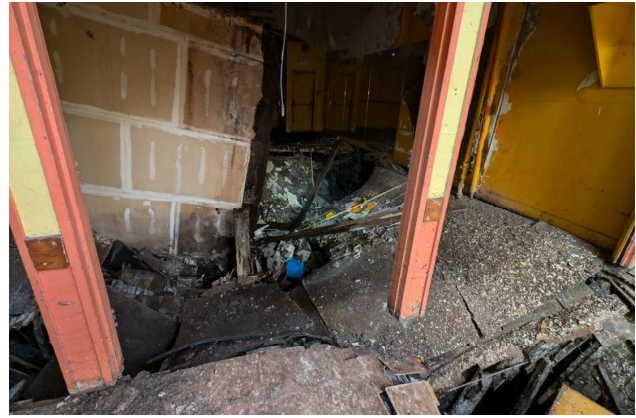
Figure 22, Complete floor structural collapse.

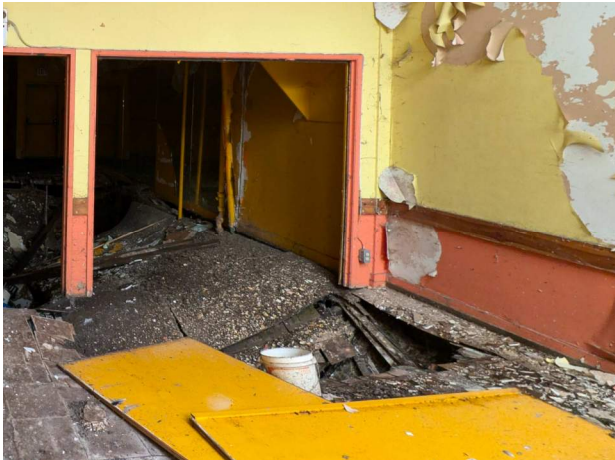
Figure 23, Complete floor structural collapse.

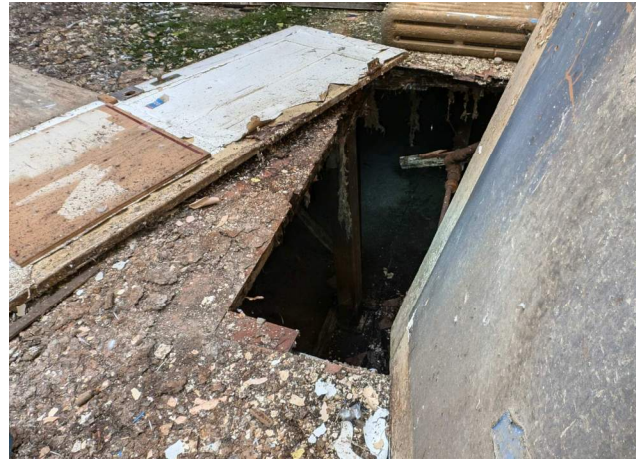
Figure 24, Localized floor collapse.

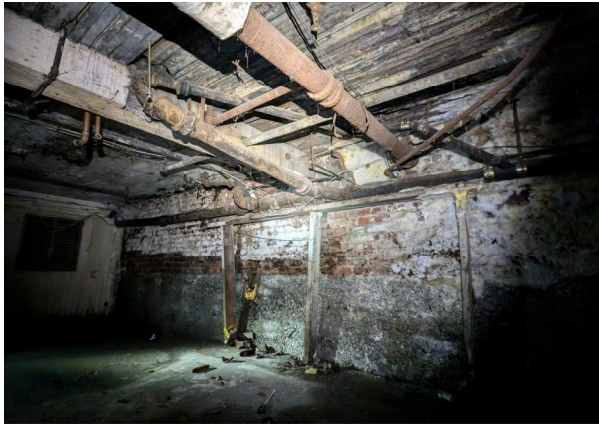
Like the upper floors and roof, this floor level had extensive water damage and rot. The damp environment of the basement has allowed extensive growth of mold on the walls and ceiling of the basement. This has also likely exacerbated the extent of rot in these timber members especially in areas exposed repeatedly to water ingress (Figures 25 through 28).

Figure 25, Floor rot, mold and compromised beam.

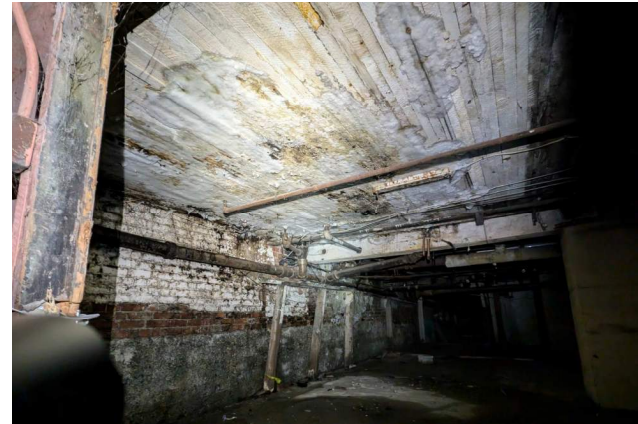
Figure 26, Floor rot and mold.

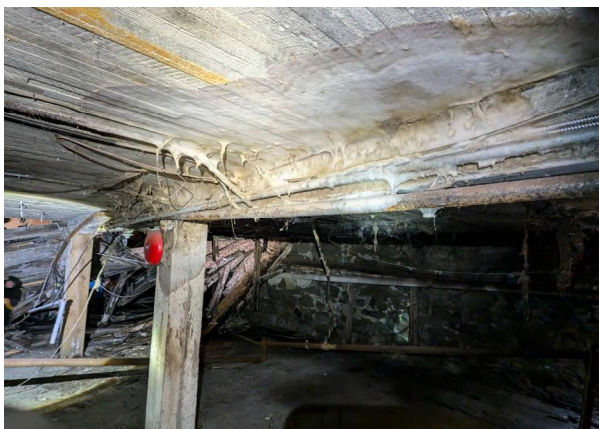
Figure 27, Floor rot, beam rot and mold.

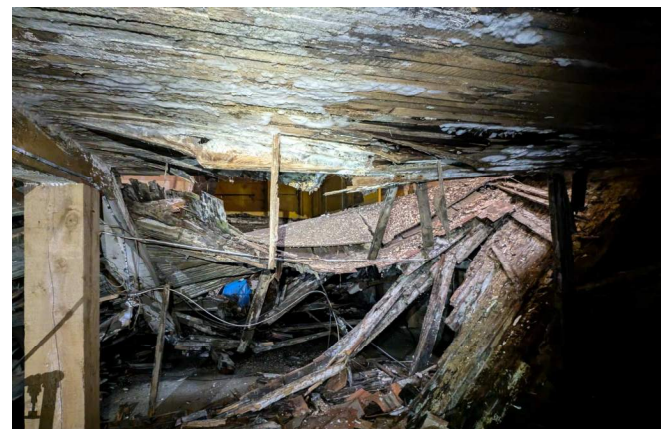
Figure 28, Collapsed floor, and rotten floor.

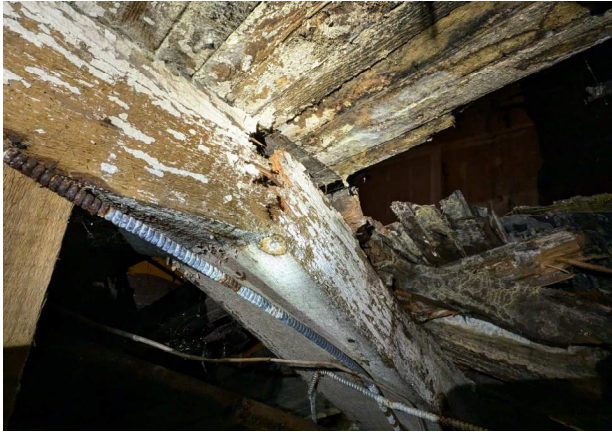
The collapsed area visible from the main floor could be clearly seen and further inspected. A fully rotten timber beam was noted (figure 29) as well as a crushed rotten timber. It is interesting to note that this collapsed floor area does not support any weight from the upper floors. The collapse of this area would have been triggered only by its self-weight, hence an indication of very extensive structural decay caused by rot.

Figure 29, Fully failed rotten beam.

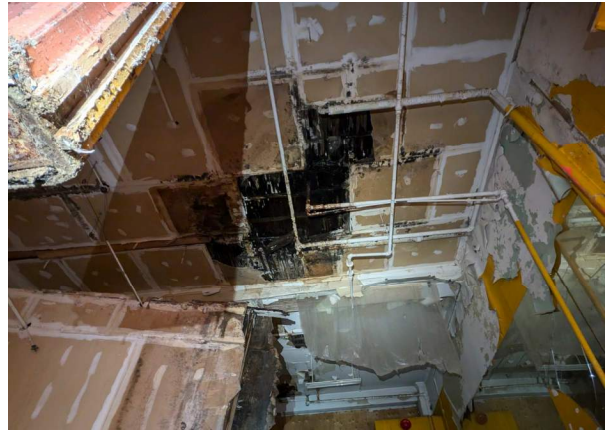
The extent of the 2nd floor damage/rot was more apparent from the basement vantage point (Figure 30). Unlike the main floor, as noted in the previous paragraph, the 2nd floor does support significant weight accumulated from the upper floors and the roof. Further localized floor collapse and possibly cascading floor collapse of all the upper floors in this area is to be expected and possibly imminent.

Figure 30, 2nd floor rot as seen from the basement.

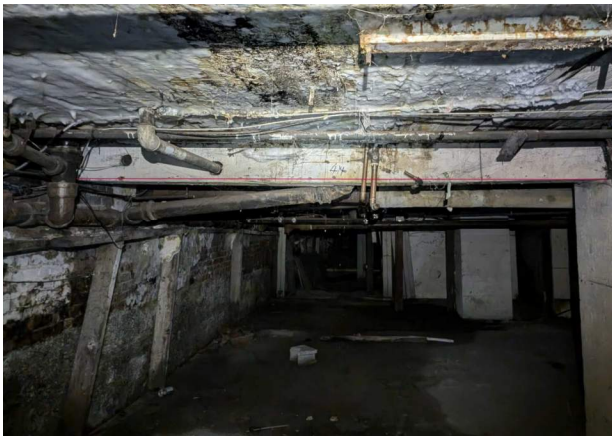
Figure 31, Deflection with red line for reference.

Several timber beams had signs of structural distress because of beam modifications such as notches for plumbing and electrical (Figure 31 through 33). Some of these beams also had pronounced deflections further indicating structural overload and/or creep caused by moisture and rot (Figure 34).

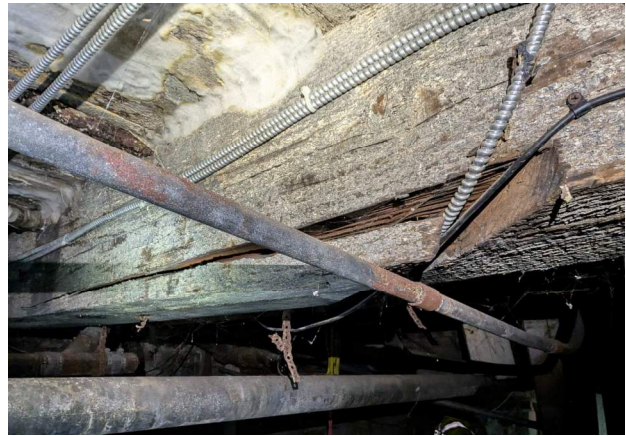
Figure 32, Failed beam due to notch for wire.

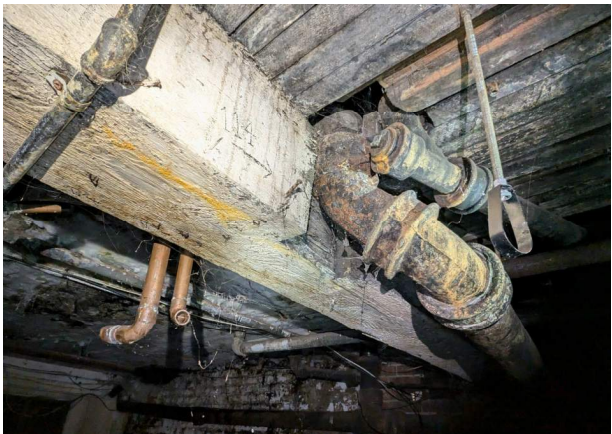
Figure 33, Failed beam due to side notch for pipe.

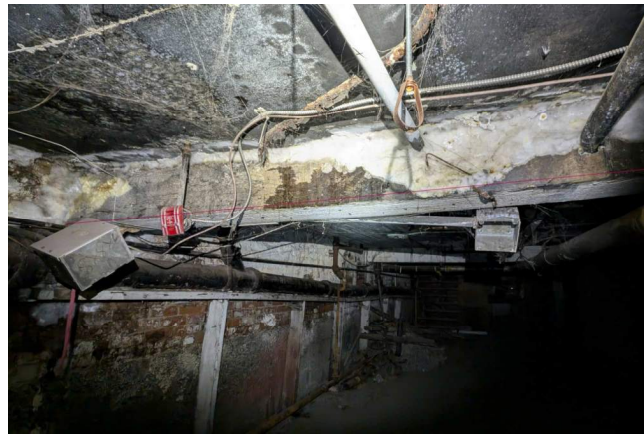
Figure 34, Deflection with red line for reference.

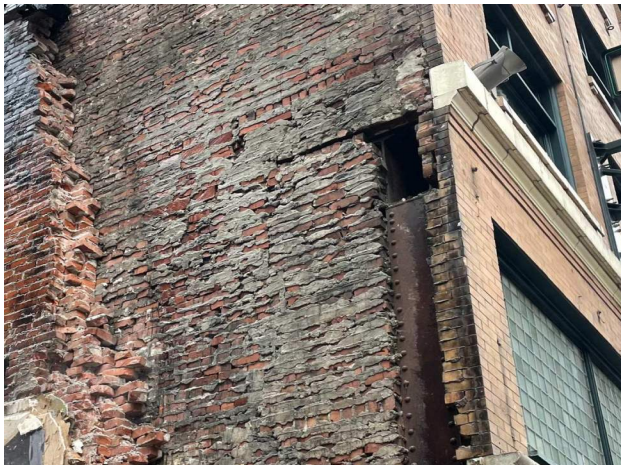
The exterior of the building façade consists of multi-wythe brick walls and brick clad steel columns (Figure 35, note this figure is not of this building but is an example of multi-wythe brick construction and typical steel beams with steel columns supporting upper levels of brick facade). The upper levels of brick walls along Richards St. and Dunsmuir St. are likely supported by steel beams (not visible, but typical construction for a building of this age). The skylight alcove at the rear of the building is clad with stucco and suspected to not be a brick substrate but likely terracotta infill and/or 2x wood stud walls (Figure 36).

Figure 35, Example of steel beam/column support.

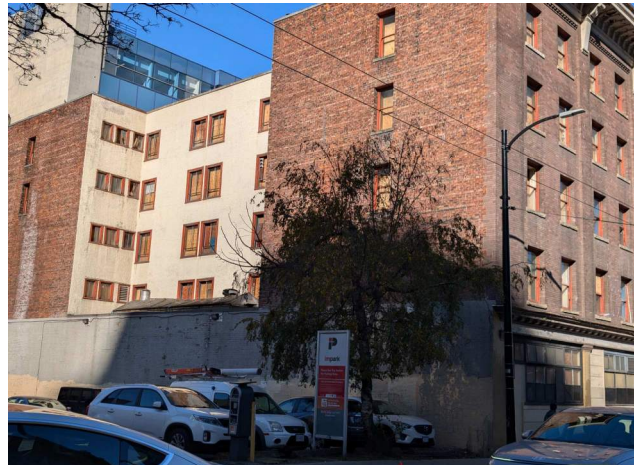
Figure 36, Rear alcove façade at parking lot.

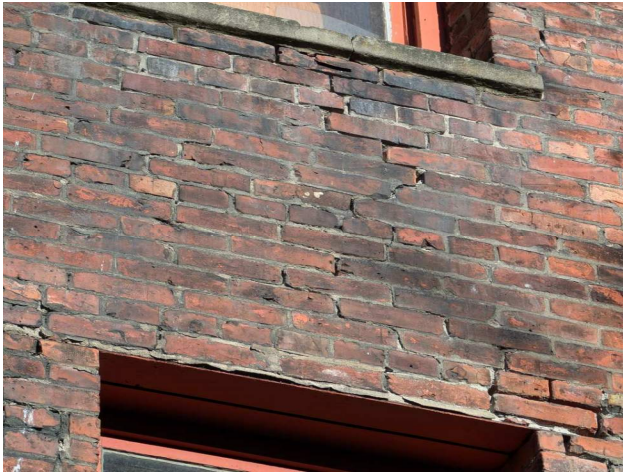
Localized areas of brick showed signs of in-plane vertical shear stress, failed mortar and brick spalling (see figures 37 through 40). Further investigation would be required to determine the full depth and extent of these cracks. The stucco clad alcove at the rear of the building also has cracking both vertical and horizontal (Figures 41 and 42). As the substrate for the stucco is assumed to be a different material than brick, these cracks are likely the result of movement seen between dissimilar materials (i.e., vertical cracks between brick and terracotta infill and the horizontal cracks from shrinkage of wood at each floor level).

Figure 37, Vertical shear cracks and mortar loss.

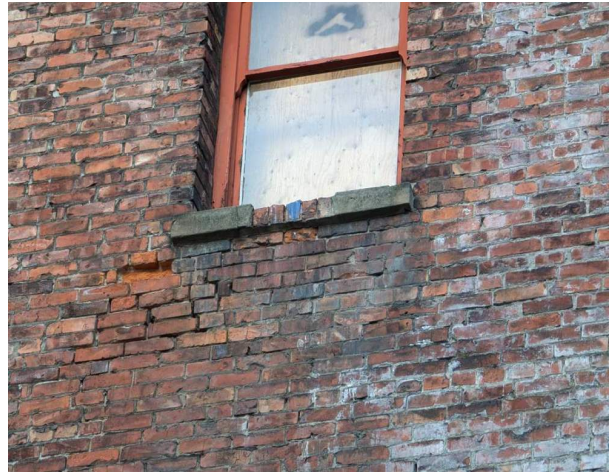
Figure 38, Mortar loss and degraded brick.

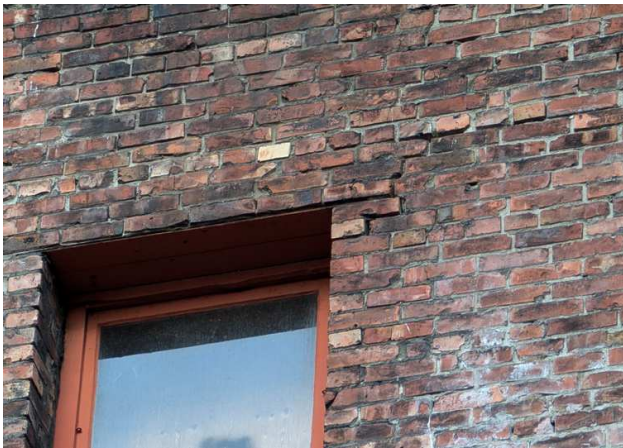
Figure 39, Diagonal shear cracks.

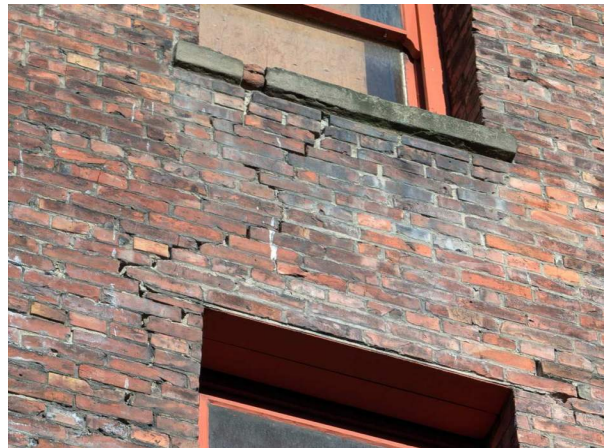
Figure 40, Diagonal shear cracks.

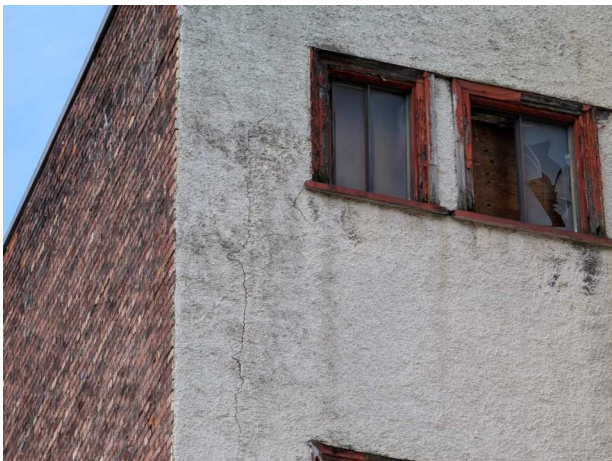
Figure 41, Vertical interface cracks.

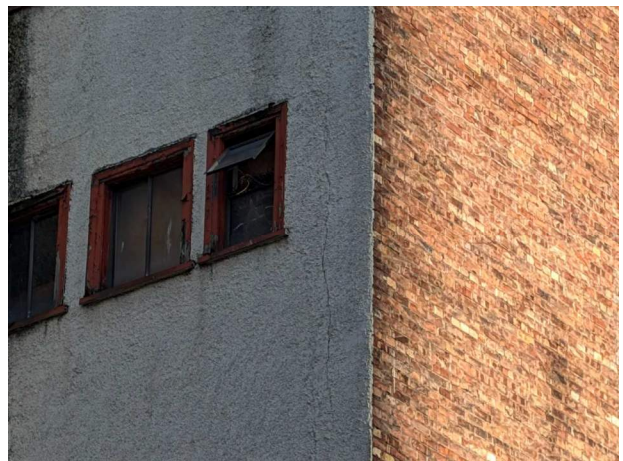
Figure 42, Vertical and horizontal interface cracks.

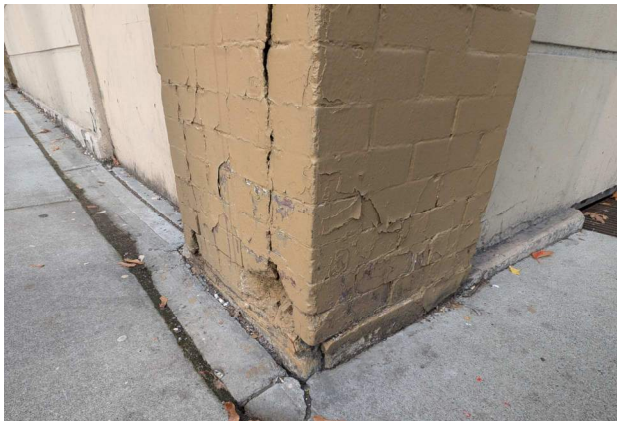
As previously noted, the brick façade along Richards St. and Dunsmuir St. is supported by steel beams on steel columns (see Figure 35 as an example). The base of these steel columns are clad with a single wythe of brick. At the base of some of these columns, the bricks are cracked, spalling and in some locations, bricks are missing (Figure 43). In some locations, the steel base plates of the steel columns are exposed and rusting (Figure 44). At one column location, the brick cladding has laterally buckled out of plane from the face of the building exposing the steel column behind (Figure 45 and 46). The extent of lateral movement is approximately 2in, as seen in Figure 46, using the vertically plumb column in the foreground. The cause of the brick cladding movement is unknown but suspected due to degradation at the base of the steel column.

Figure 43, Cracking, spalling of column cladding.

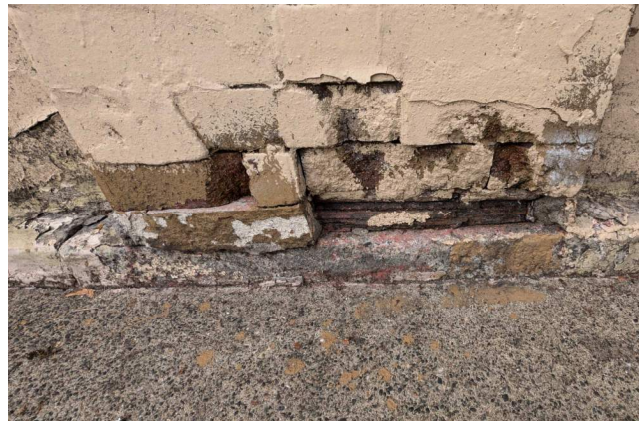
Figure 44, Steel column baseplate exposed & rusting.

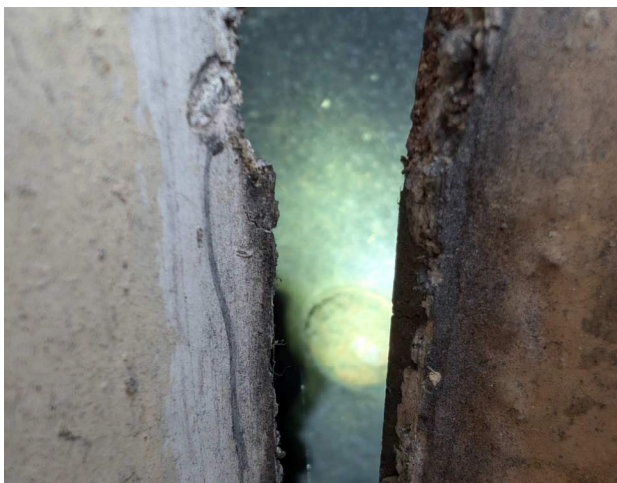
Figure 45, Rivet of steel column seen through crack.

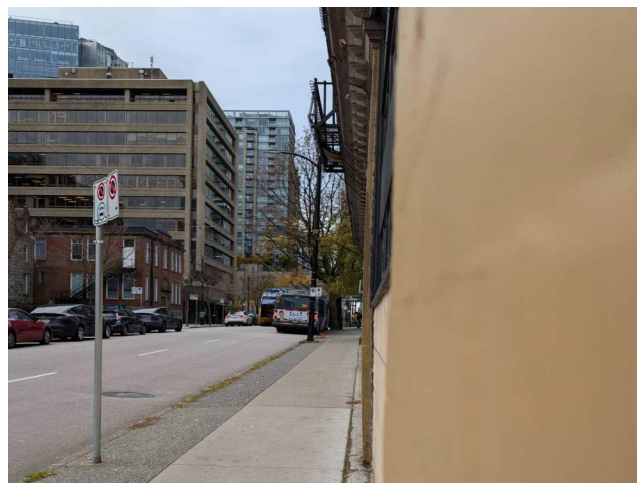
Figure 46, Laterally buckled brick column cladding.

The lateral out of plane buckling of the brick cladding at the steel column indicates that some vertical movement of the steel column has occurred. The exact cause of this movement is unknown; however, the brick cladding at the column on Richards St. has the potential to fully buckle and collapse onto the sidewalk.

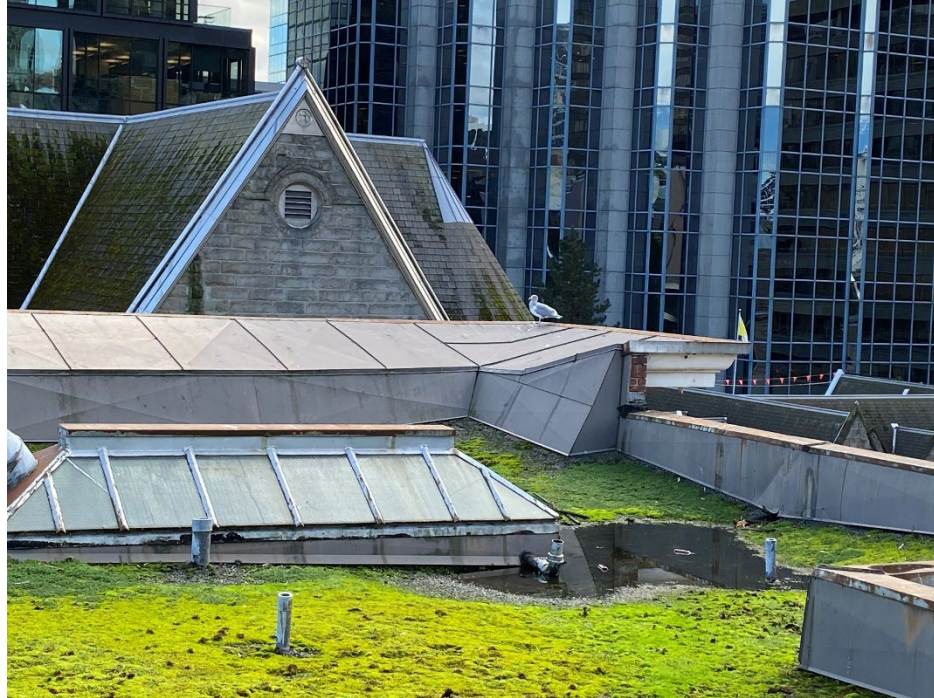
Water ponding on roof near SE skylight

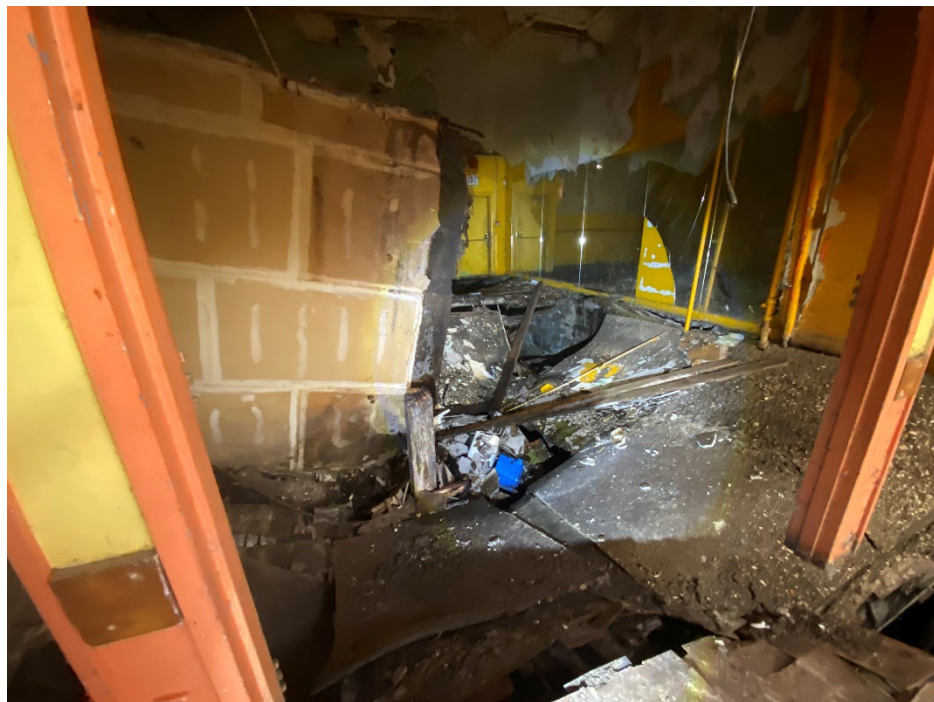
Ground floor collapsed into basement below SE skylight

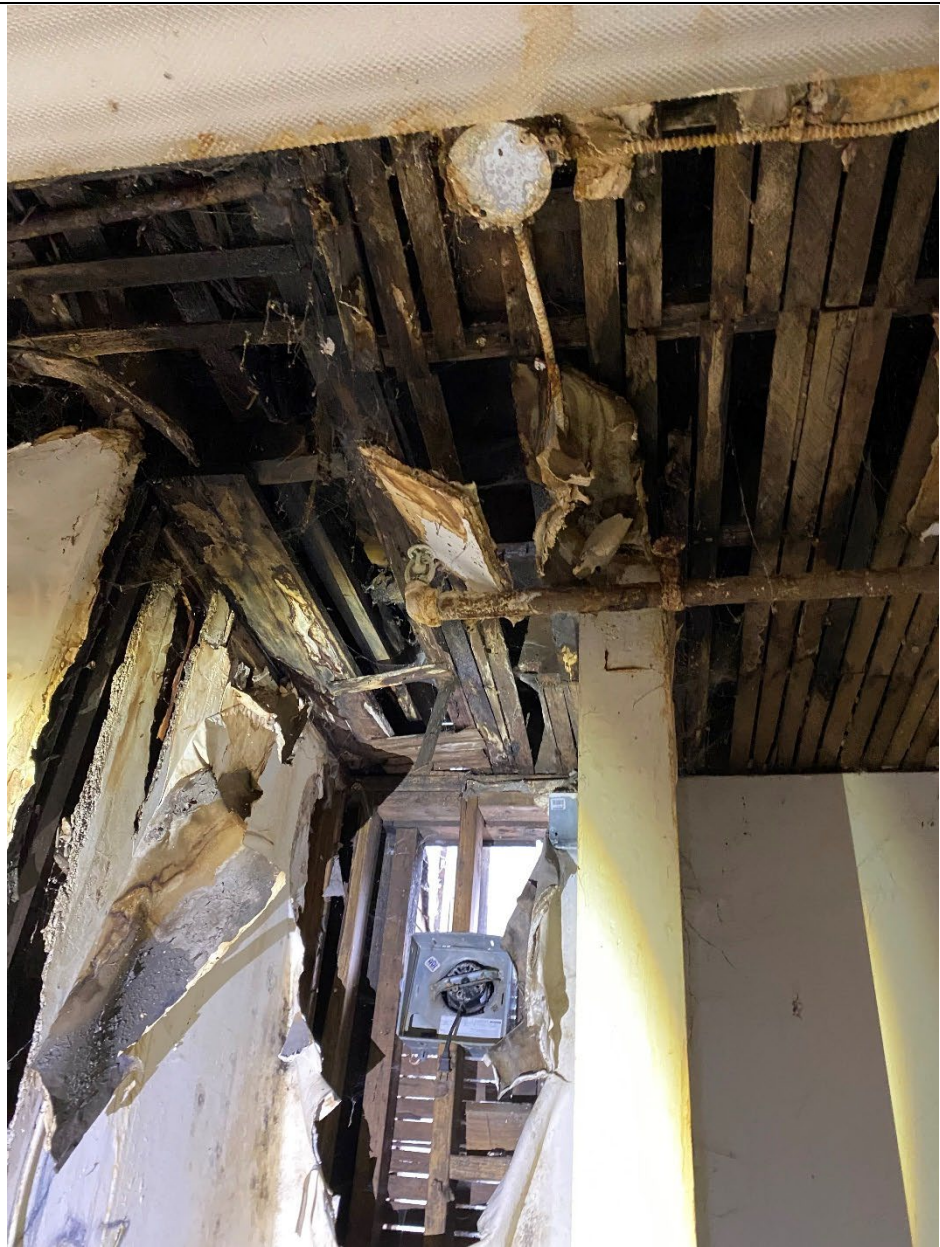
Typical Condition below SE skylight
