## COUNCIL REPORT

SUBJECT: Heritage Incentive Program (HIP) 2024 Update and Grant Recommendation for 355 Burrard Street (Marine Building)

355 BURRARD STREET, VANCOUVER, BC

## FACADE CONSERVATION PLAN

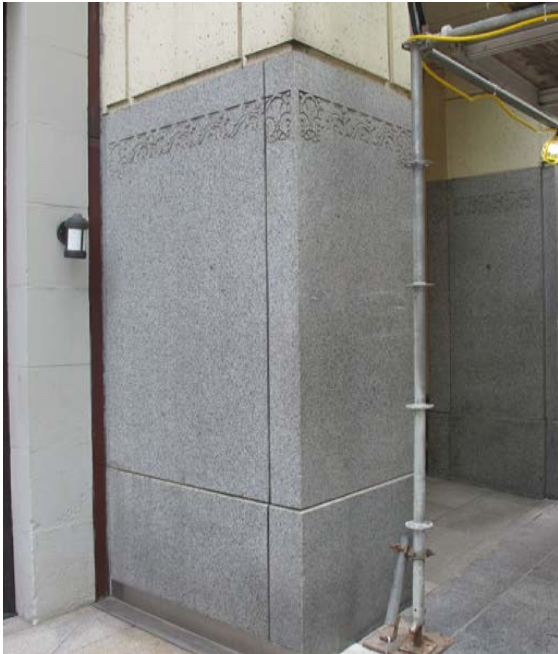
The base of the Marine Building is clad in panels of polished grey granite with a carved floral band at the top of the panels on the West Hastings and Burrard Street facades. The panels are sloped below the windows of these street facades. The granite is original to the building's construction and overall in good condition. There are localized chips and staining (primarily at the bottom of the panels) of the granite in areas.

*Typical grey granite panels with floral band motif, 2024 (DLA).*

- Preserve the building's grey granite panels.
- Anchor granite to back up structure or concrete encased columns depending on location. Complete anchoring in manner that does not alter its appearance.
- Repoint deteriorated mortar joints and at anchor points.

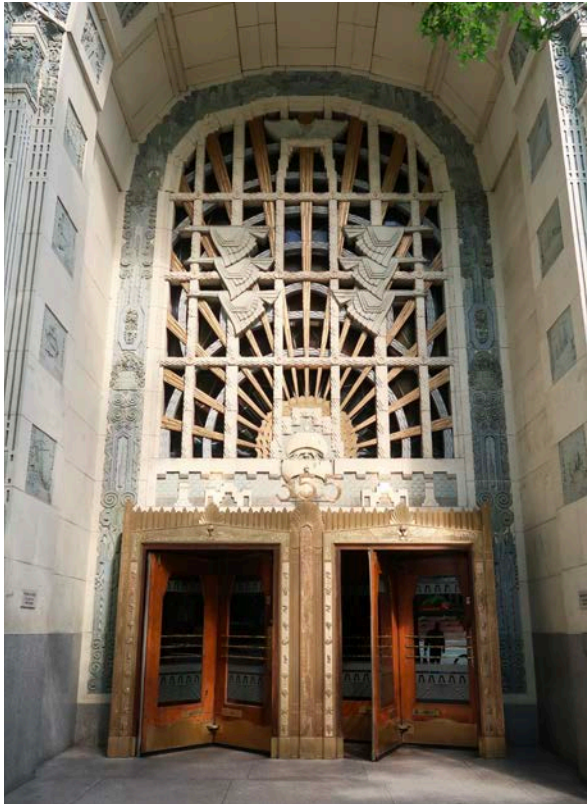
cracks, chips, spalled areas exposing the biscuit, and past unsympathetic repairs. The nature and condition of the anchoring of the terra cotta to the back up structure is unknown.

Previous page and this page: Examples of terra cotta use on the Marine Building, 2024. (DLA, Google)

- Retain the original glazed terra cotta of the exterior of the Marine Building.
- Anchor terra cotta in identified work areas. Anchor through mortar joints to minimize impact to terra cotta.
- Repair cracked and damaged terra cotta. Where repair mortars are used, ensure mortar is suitable for use with historic terra cotta. Repaired appearance to match appearance and finish of original unrepaired terra cotta.

- Where terra cotta is cleaned, do not use any abrasive methods that may damage the glazed surface. Only approved restoration cleaners may be used. Sandblasting or any other abrasive cleaning method of any kind is not permitted.
- Submittals to be reviewed by Consultants. Mock ups of cleaning, anchoring, repairs, and repointing to be reviewed by Consultants prior to proceeding with work.

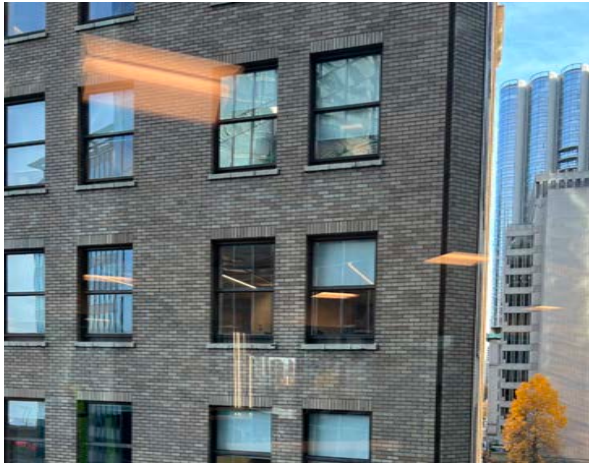
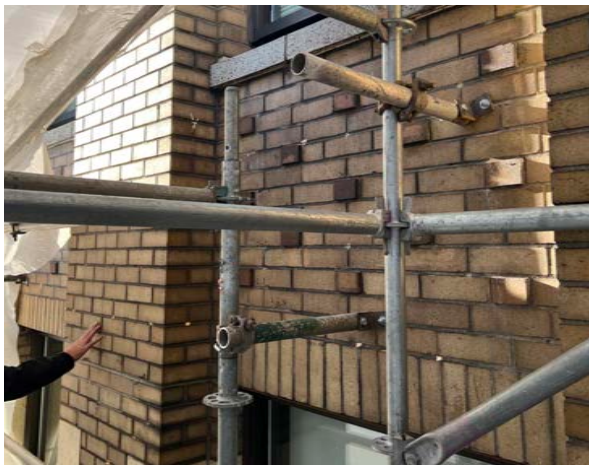
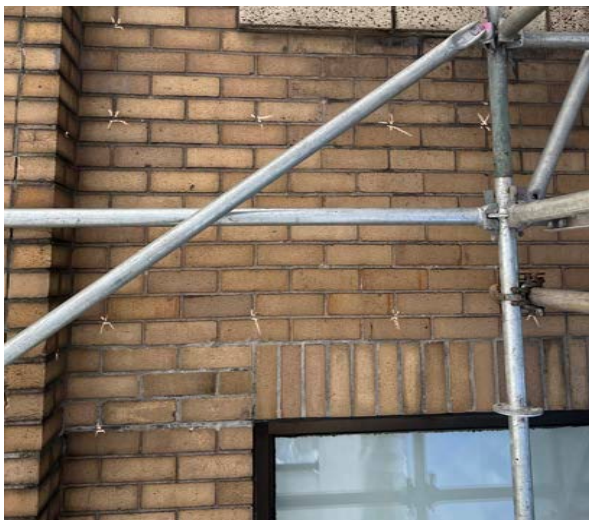
*Use, colour variation, and condition of brick on exterior facades of Marine Building, 2024. (DLA and RJC)*

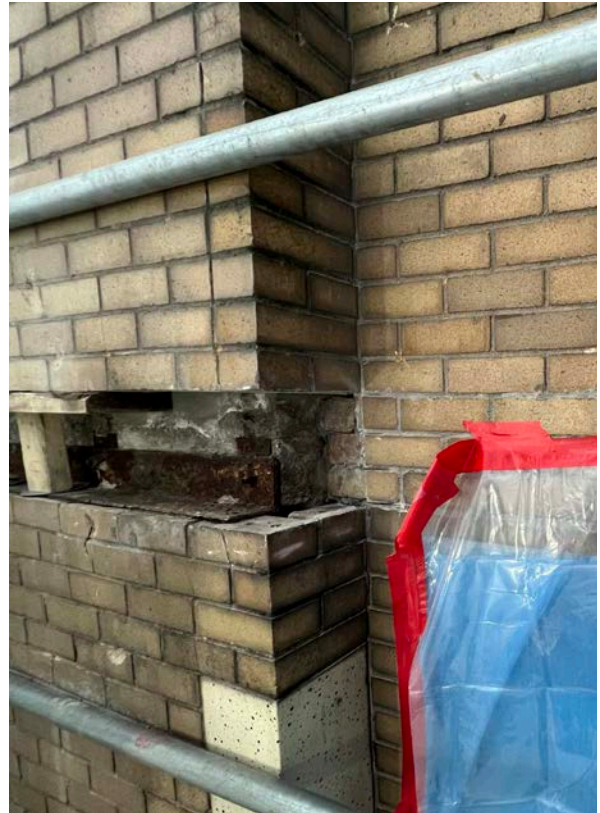
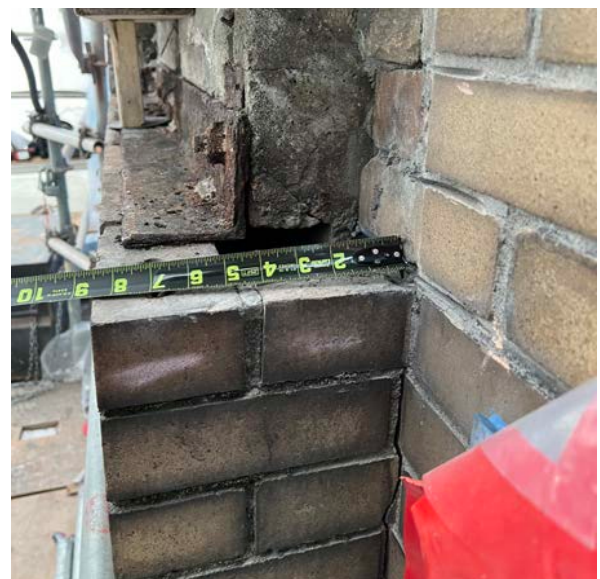
*Top and Bottom: Condition of brick showing cracks at mortar joints and through brick, and past repointing work. Corroded condition of existing shelf angle and lack of shelf angle on return shown, 2024. (RJC)*

shelf angles existed at the slab edge only and did not extend at the returns of the pilasters. This detail, as well as the corrosion of the existing shelf angles, are considered to be contributing factors to masonry deterioration (e.g. cracking) particularly at the corner head joints and returns of the brick facade.

The proposed interventions to address the deteriorated brick of the identified scope areas (see RJC drawings R.301 and R.302 dated 2024.08.09) include: cleaning of the exterior masonry; assessment and repair or replacement of existing shelf angles; addition of shelf angles at returns; replacement of damaged brick using salvaged original or new brick that matches the original; localized repointing; and, anchoring of brick to base structure.

- Expose existing shelf angles and salvage brick in good condition that is suitable for reuse. Store salvaged brick in manner that ensures no damage will occur.

- Assess exposed shelf angles to determine if shelf angle requires cleaning and coating or replacement.
- Install new shelf angles at returns as indicated on RJC drawings.

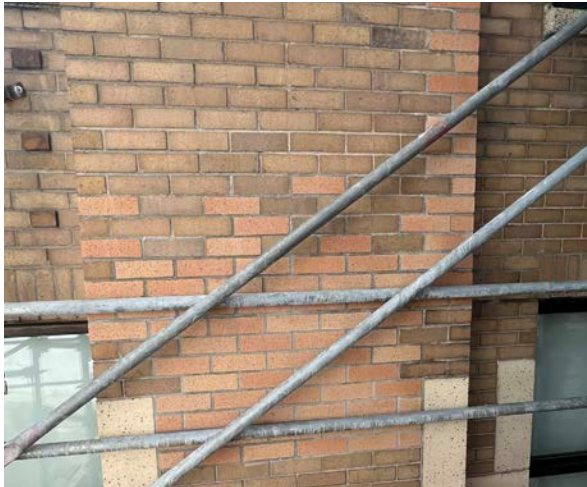
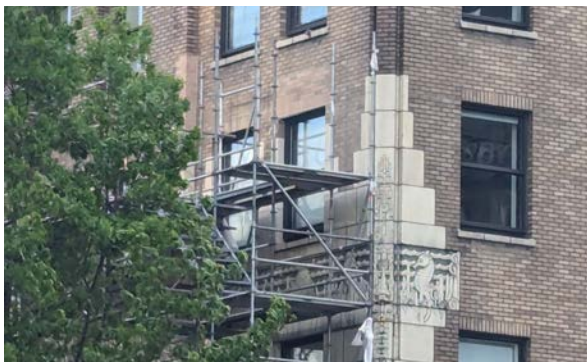
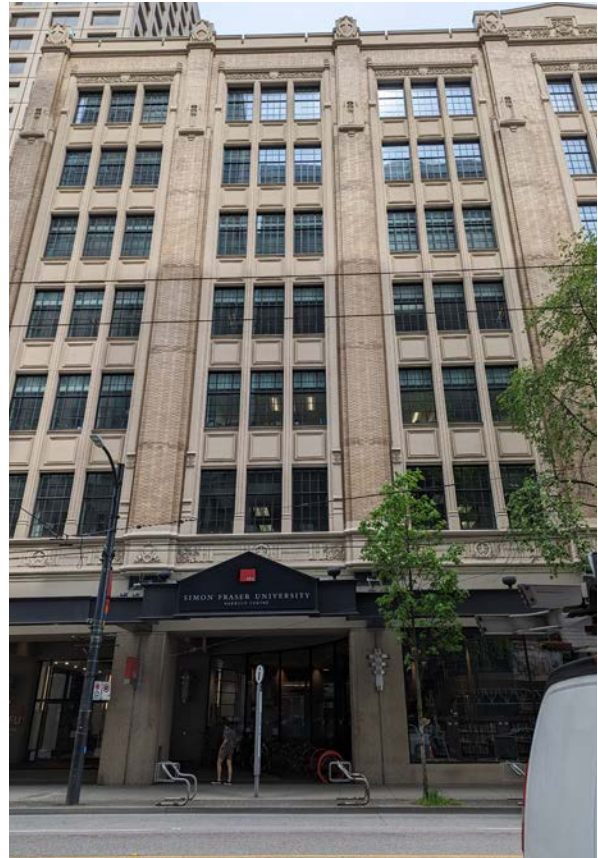
*Left Top and Bottom: Completed mock up using salvaged and new brick viewed from scaffolding and street level. Visual difference between the new brick and the existing is significant and closer colour matched brick should be considered, 2024. (RJC, DLA)*  
*Right: Example of Vancouver building where shelf angles were replaced. Note banding evident in brick where shelf angles were replaced, 2024. (DLA)*
