COUNCIL REPORT

TO: Vancouver City Council
FROM: City Building Inspector
SUBJECT: Declaration of Dangerous Building at 341 East Hastings Street, Vancouver

RE : **STRUCTURAL FIELD REVIEW REPORT: 341 E HASTINGS, VANCOUVER, BC**

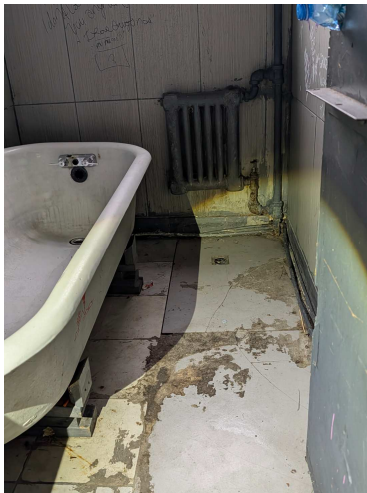
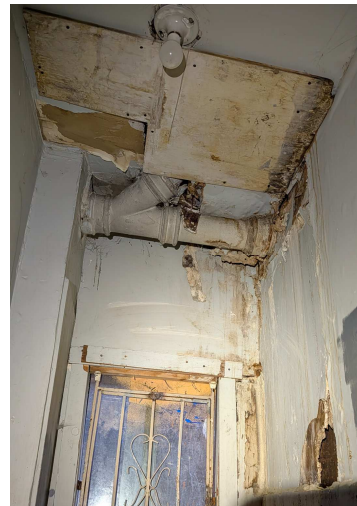
- The upper floors, particularly in and around the areas of the vertically aligned plumbing stacks (washrooms), exhibit signs of water ingress and significant deflection (Figures 1 and 2).

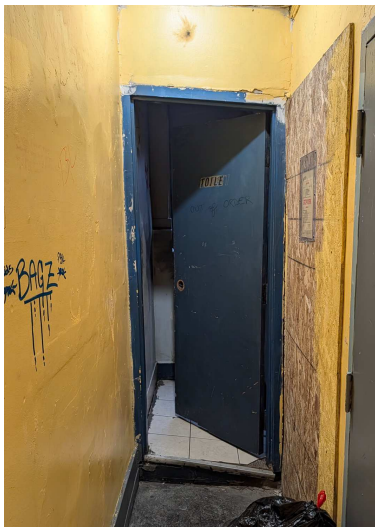
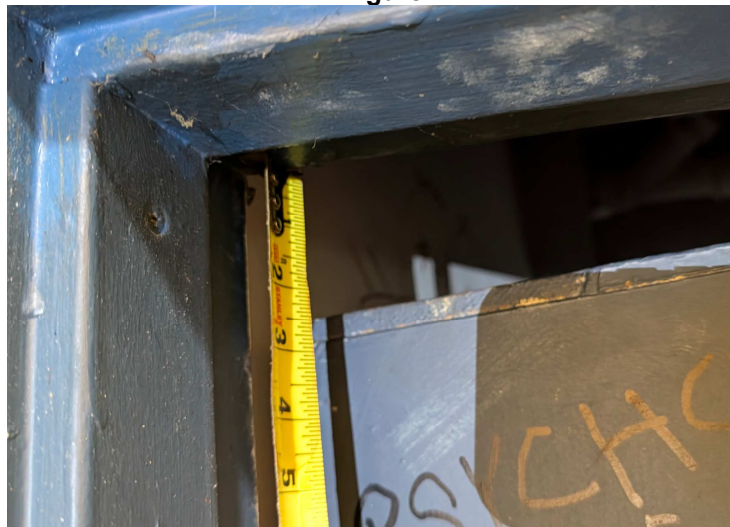
- These deflections were measured at nearly 3in over a 2.5ft span within the door frame into one of the washrooms as a point of reference (Figures 3 and 4).

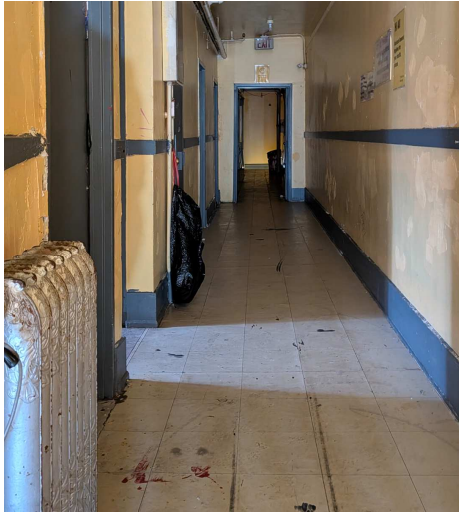
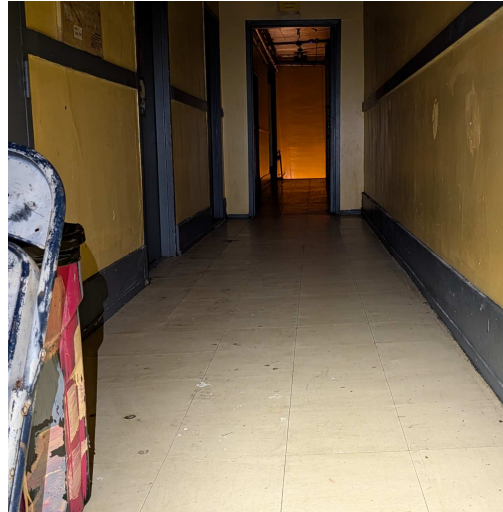
- The building also had a pronounced floor slope, moving from the exterior west wall of the hallway corridor toward the east (Figures 5 and 6). This floor slope increased in proximity to the washrooms located near the rear and east side of the building. The magnitude of this slope also increased progressing floor-by-floor down the building, with the largest slope measured on the second floor.

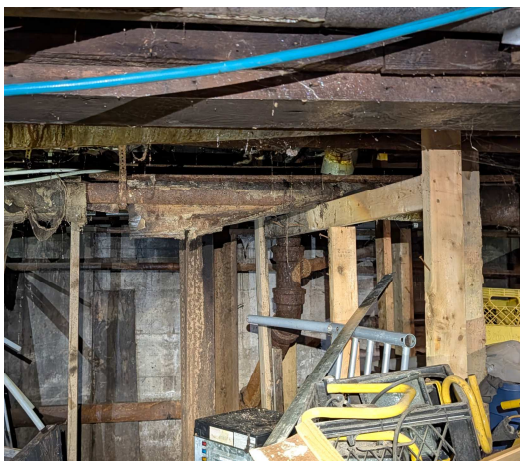
Figure 7

- This highly affected area covers approximately a 10ft wide by 16ft long segment of the basement that aligns with the stacked washrooms above.
- Much of the 6in thick NLT floor in this area has structurally failed. Non-engineered temporary supports have been installed using various sized posts (Figures 7 and 8). Many of these posts are significantly undersized, compromising their load-carrying capacity, and some are already exhibiting lateral buckling failure.

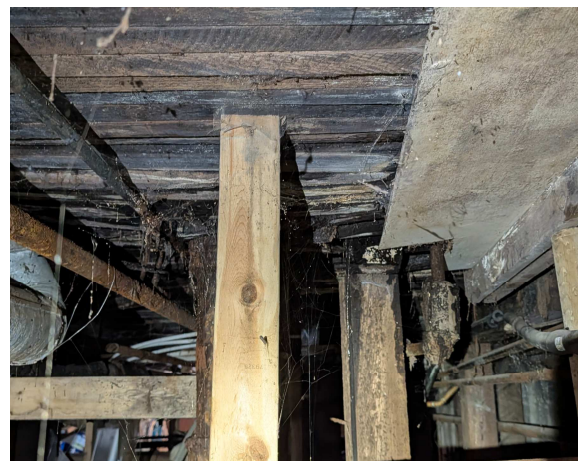
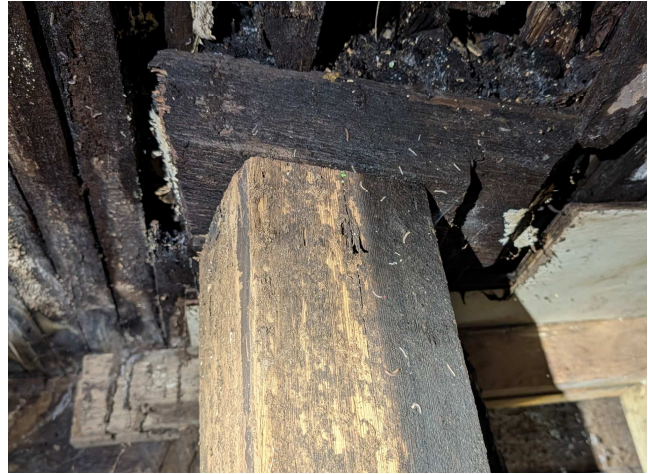
- The severity of the rot is significant, indicating prolonged moisture exposure. The installed posts are crushing through the compromised NLT and consequently providing negligible structural support for the floor above (Figures 8 and 10).

- To provide immediate structural support to the main floor, shoring is recommended in the basement area below the stacked washrooms.
- The existing posts should remain in place and be supplemented with upwards of four lines of steel post shores (running parallel to the eastern basement wall), complete with header beams and sills.
- Steel shores and the use of aluminum beams are recommended due to the high-moisture environment. If all areas contributing to moisture are repaired, timber posts and beams may be considered.
- The size and spacing of the shoring posts and header beam will require determination based on the loads from the structure above.

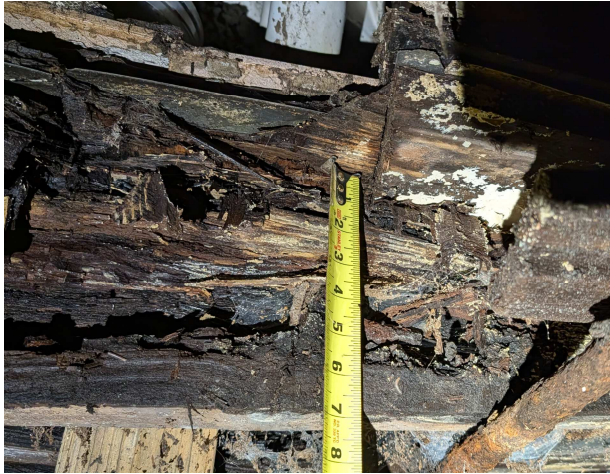
Figure 9

- The basement area directly below the stacked washrooms was extensively saturated, with advanced fungal decay visible throughout the underside of the main floor NLT structure. Segments of the NLT cross-section have completely rotted away creating advanced section loss, and in some locations, holes through to the main floor above (Figure 9).

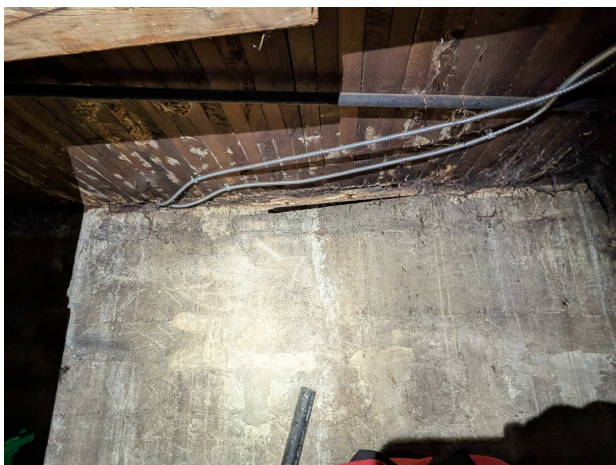
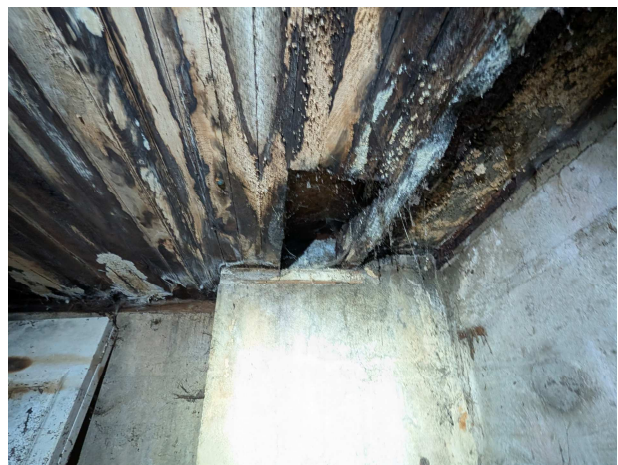
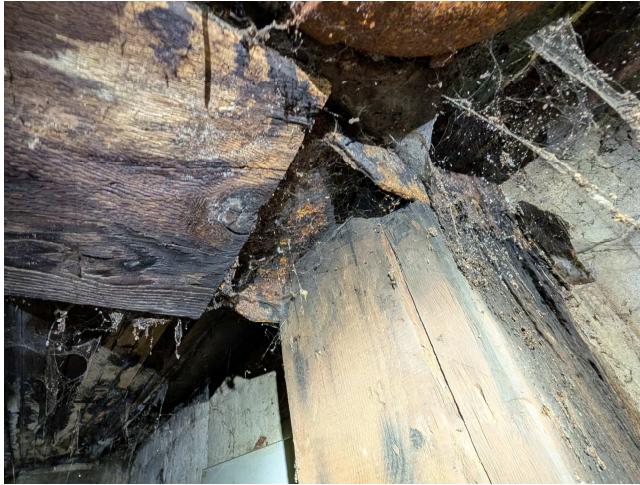
- Perimeter Conditions: Localized areas of moisture, mold, and rot are evident adjacent to the perimeter concrete basement walls. Specific observations include:
 - Wood sill plates supporting the interface between the NLT floor and the top of the concrete wall are affected by decay (Figure 11).
 - Deteriorated NLT floors and mold growth (Figure 12).
 - Rotten columns and deteriorated and/or inadequate structural load paths (Figure 13).
 - Advanced section loss on steel floor beams due to corrosion (Figure 14).

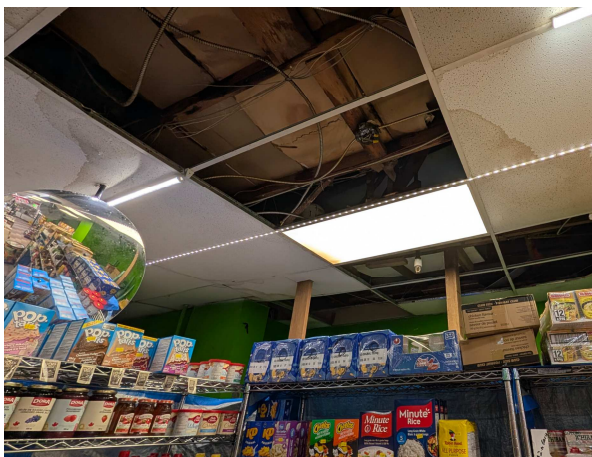
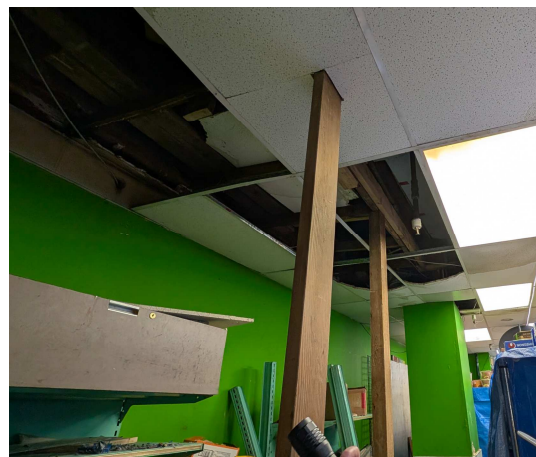
- Additional non-engineered temporary supports have been installed, though their intended purpose (support for the second floor and/or support for non-structural secondary ceiling elements) is unclear (Figures 15 and 16).
- The severity of moisture-induced deterioration and localized areas of rot in the wood members of the ceiling indicate prolonged moisture exposure.

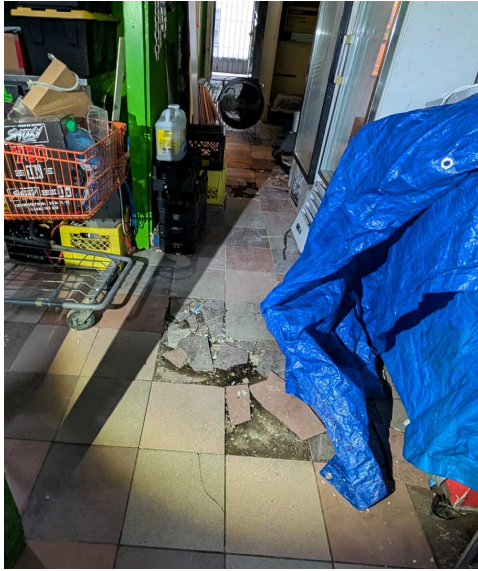
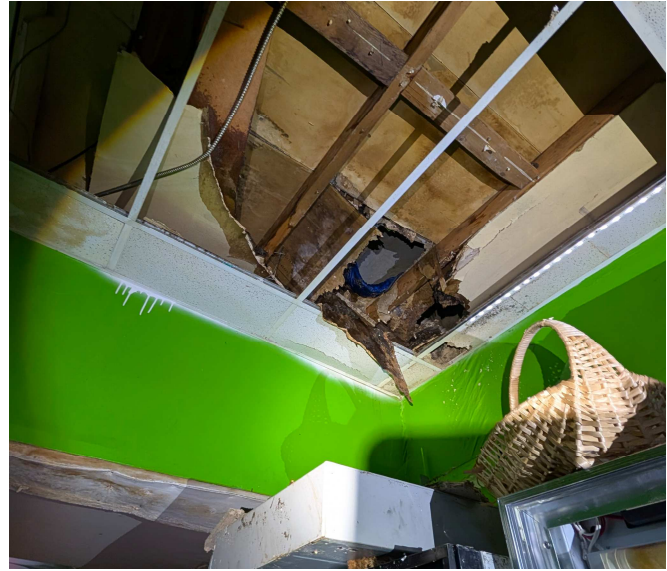
Main Floor Retail Space: The retail space on the main floor reflects the degree of deterioration seen in the basement, exhibiting loose/missing floor tiles, moisture issues, and mold (Figures 17 and 18).

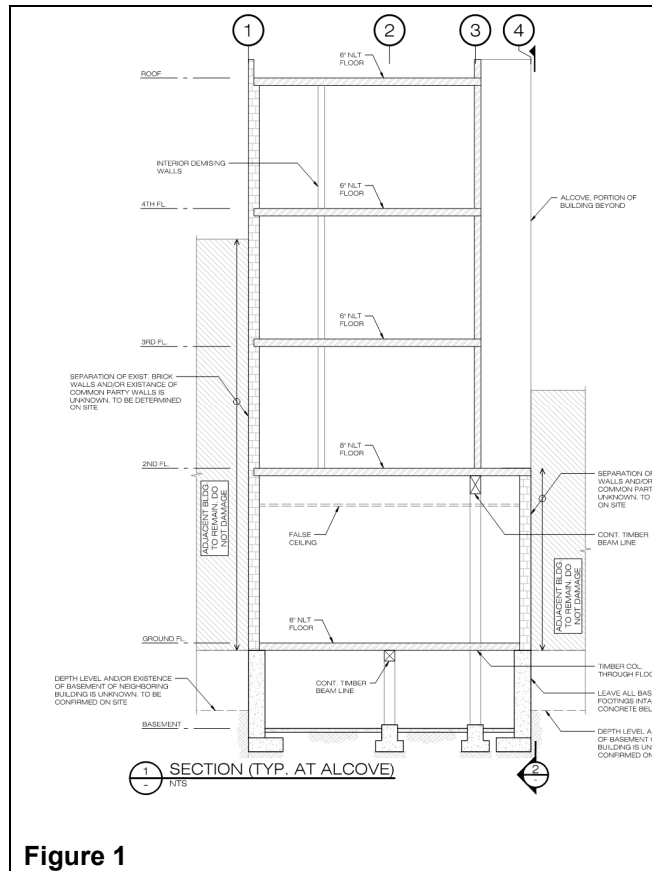
Figure 1

The inspection confirmed that the second floor is, in fact, a transfer level supporting the entirety of the upper structures (Floors 2, 3 and 4) and the roof.

The second-floor NLT system spans approximately 20ft from the west exterior wall (Gridline 1 per Figure 1) to an interior column and beam line (Gridline 3 per Figure 1) located directly under the alcove of the east exterior wall. The NLT floor then continues east for another 5ft to the most easterly exterior wall (Gridline 4 per Figure 1) that aligns with the exterior wall of the basement.

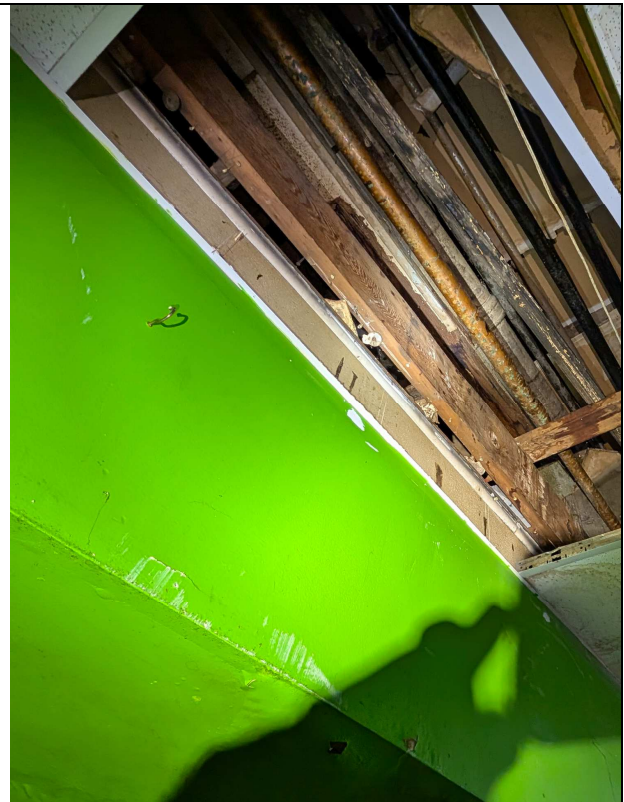
Figure 2

Via the access opening cut into the main floor ceiling (Figure 2), the beam on Gridline 3 is visible directly beneath the stacked washrooms.

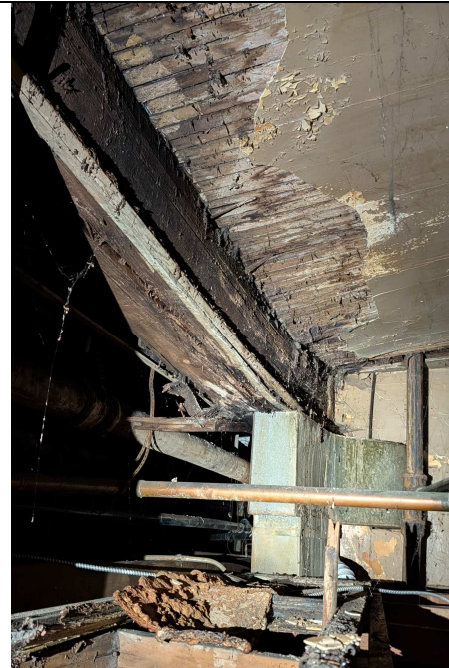
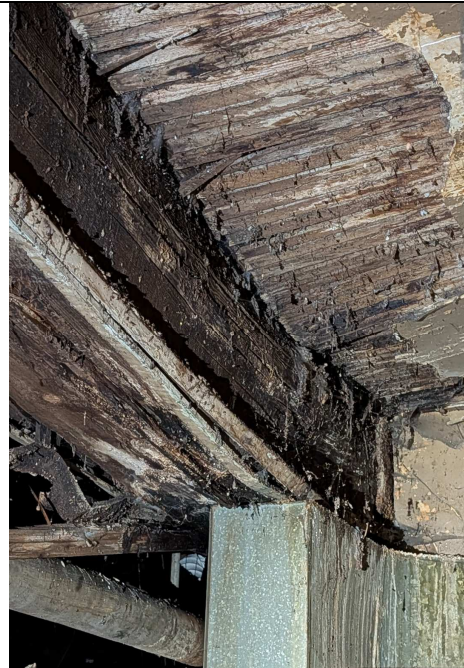
- **Beam Failure:** The 10in wide by 20in deep timber beam has fully rotted, fractured, and failed at its mid-span.
- **Deflection:** The estimated deflection of the beam is in excess of 8in, which aligns with the excessive deflections previously measured on the upper floors.
- **Decay Extent:** Extensive timber decay (rot) is apparent throughout this area, including the timber beam (Figures 3 through 6). The condition of the supporting timber column is currently unknown; however, given its proximity to the severely affected area, it is suspected that the column also exhibits a significant degree of fungal decay and structural compromise.
- **NLT Deterioration:** The NLT floor, which also serves as the roof on the east side of this beam, has rotted out and further dropped down along the side of the beam (ceiling on the right side of the beam as seen in Figures 5 and 6).

Shoring is immediately required to support the second floor due to the confirmed failure of the primary transfer beam.

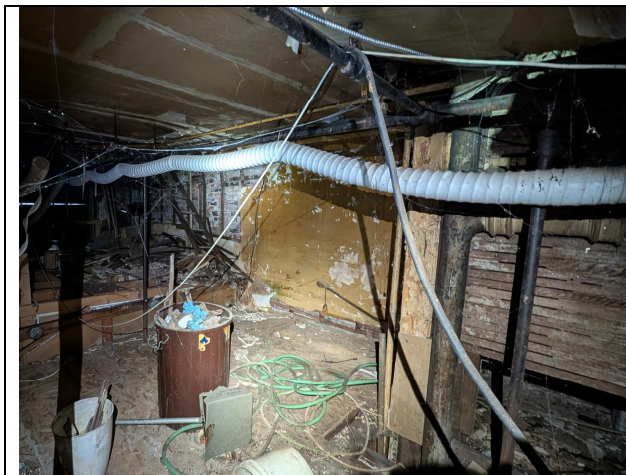
Figure 7

Further visual access was provided via a mezzanine structure that was subsequently found hidden behind a portion of the main floor wall assembly (Figure 7).

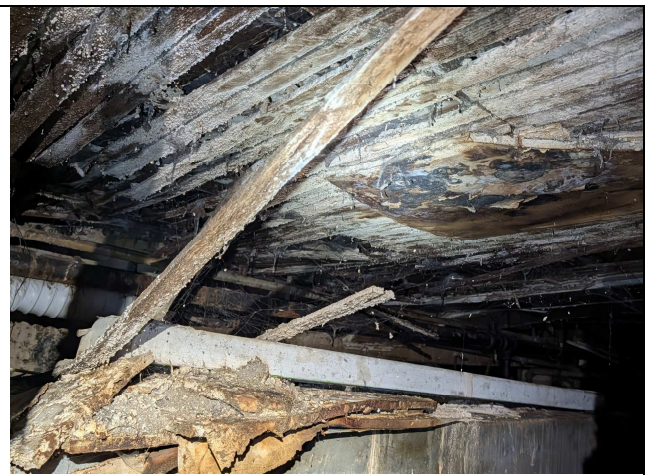
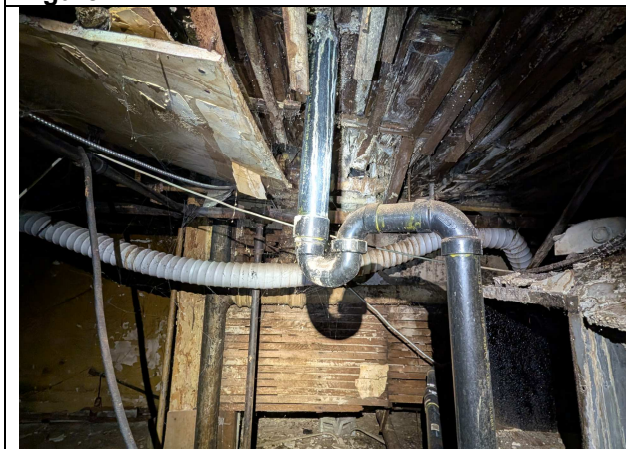
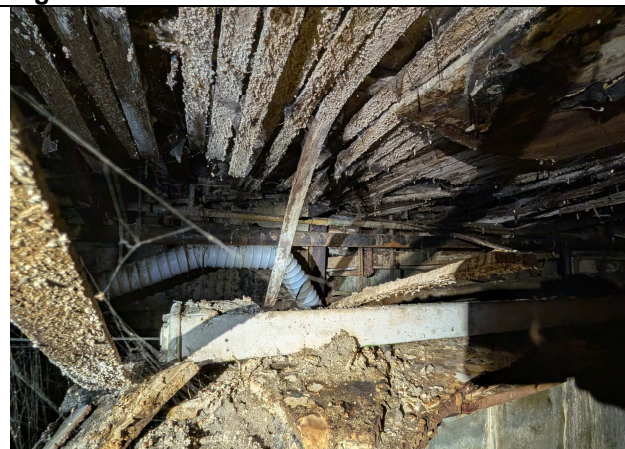
- The area directly below the stacked washrooms is extensively saturated, with advanced fungal decay visible throughout the underside of the second floor NLT structure (Figure 8).
- Segments of the NLT cross-section have completely rotted away, creating advanced section loss, and in some locations, holes penetrate through to the second floor above (Figure 9).
- This highly affected zone covers approximately a 10ft wide by 16ft long segment of the second floor that aligns with the stacked washrooms above. Much of the 8in thick NLT floor in this area has structurally failed (Figure 10).
- The severity of the rot is significant, indicating prolonged moisture exposure.
