PROJECT TITLE
5872 WALES STREET
VANCOUVER B.C.

SHEET TITLE
DPA HERITAGE HOUSE
ELEVATIONS

TREE REPORT

5872 Wales

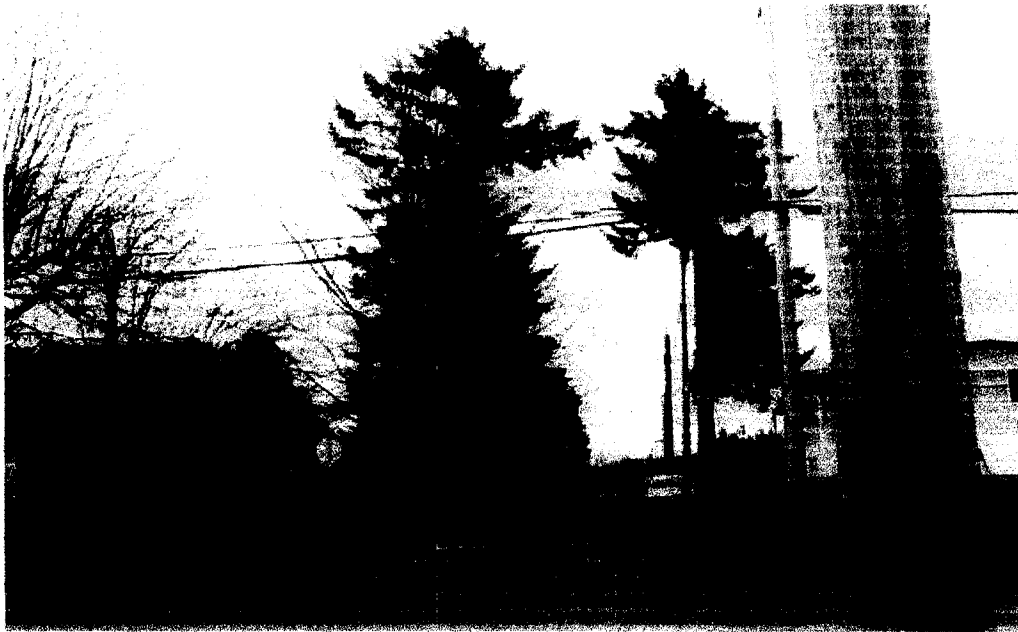
Photo #1 – Subject trees are definitely dominant trees in the neighbourhood, note the trees to the South have been pruned for clearance to the hydro lines while the subject trees have only been minorly trimmed. These trees to the South also have substantial fill at the base. Subject trees are unaltered and no changes to grade around base.

The site is a developed large lot with grass and a hedge in close proximity to the trees. The road is located 3 meters to the South of the trees and 3 phase hydro lines do run perpendicular to the trees but are not that close to the trees.

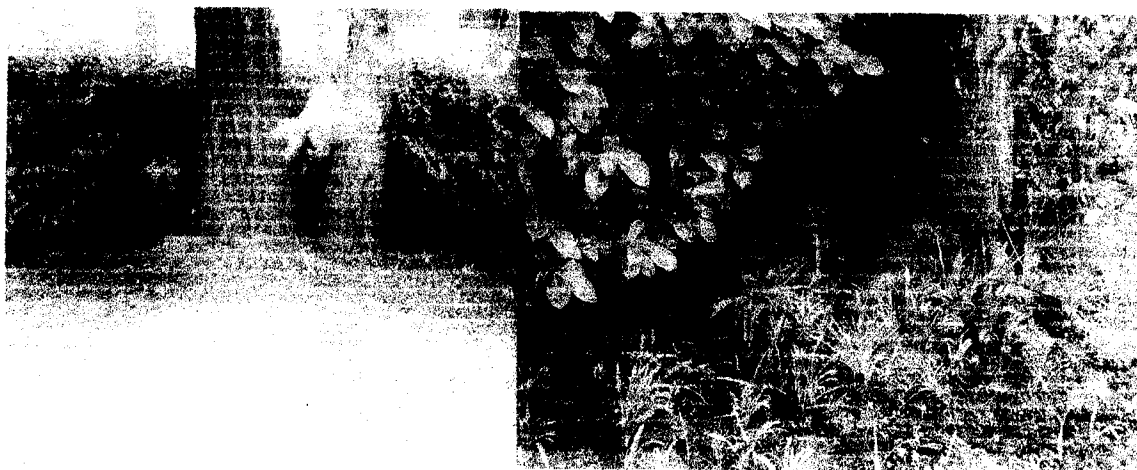
Photos #4 – Base of the subject trees all appear at natural grade and in excellent condition.

The grade has not been raised or altered in any way detrimental to the trees
