ADMINISTRATIVE REPORT

SUBJECT: 564 Beatty Street (DE 414716) - Heritage Designation, Heritage

Revitalization Agreement and Incentives

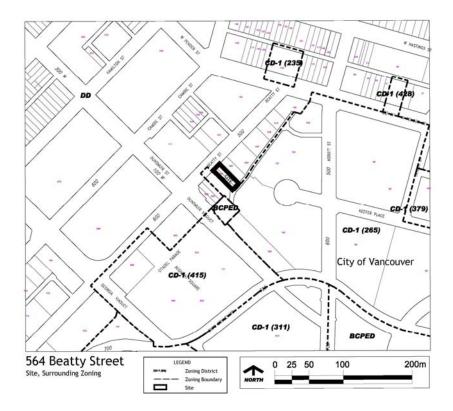
564 Beatty Street - Site Plan

Located near the north-east corner of Beatty and Dunsmuir streets, the 564 Beatty Street site forms a gate post at the eastern edge of the downtown plateau. Situated next to the Stadium Skytrain station, at the foot of the Dunsmuir bike lane and only four blocks from the West Coast Express & Sea Bus terminal, this site is uniquely positioned for convenient access to a variety of transportation modes.
