Cambie Bridge Interim Active Transportation Improvements

- Background
- Current Conditions
- Design
- Cycling Connections
- Implementation

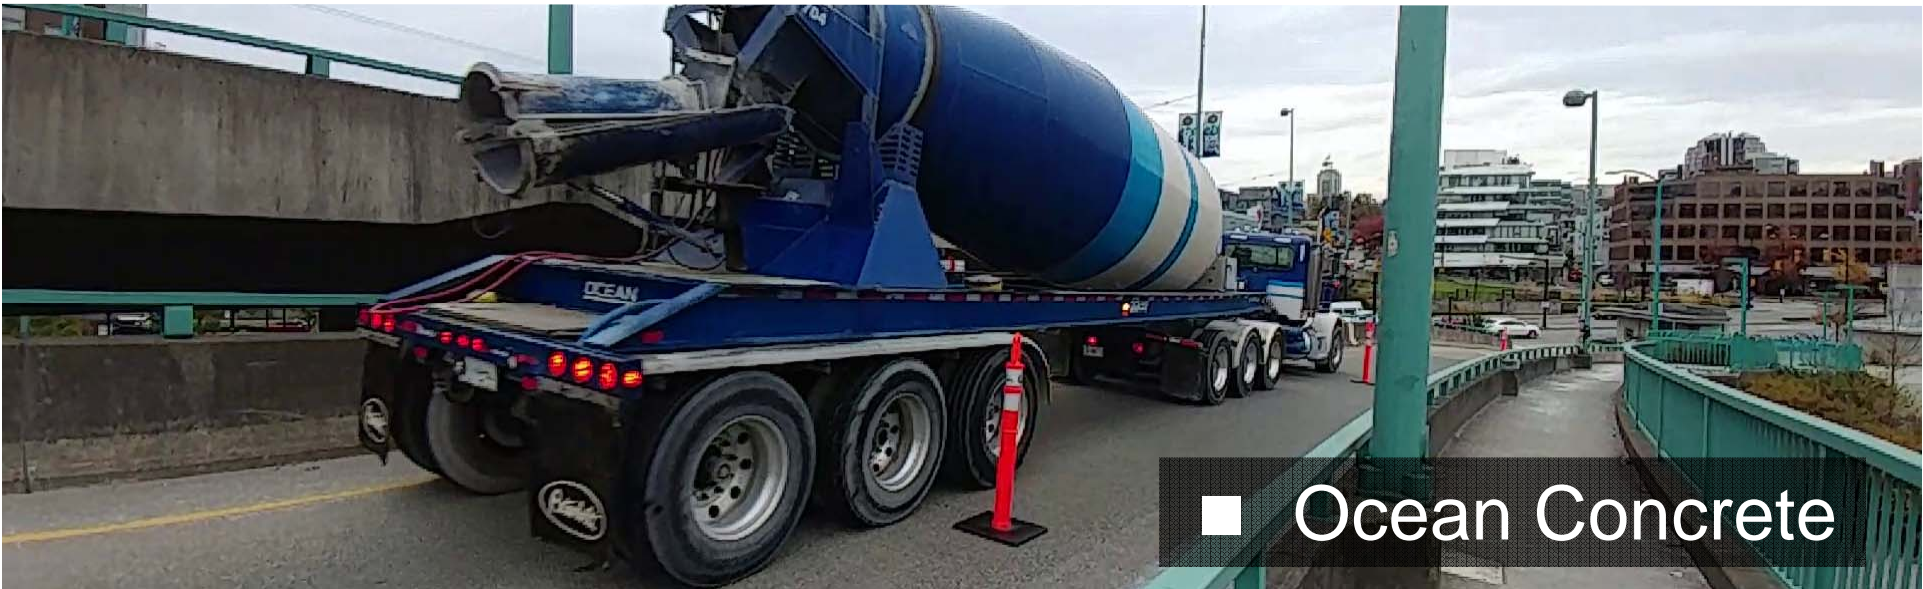
Design Refinements: Ramp Width Test

■ Ocean Concrete

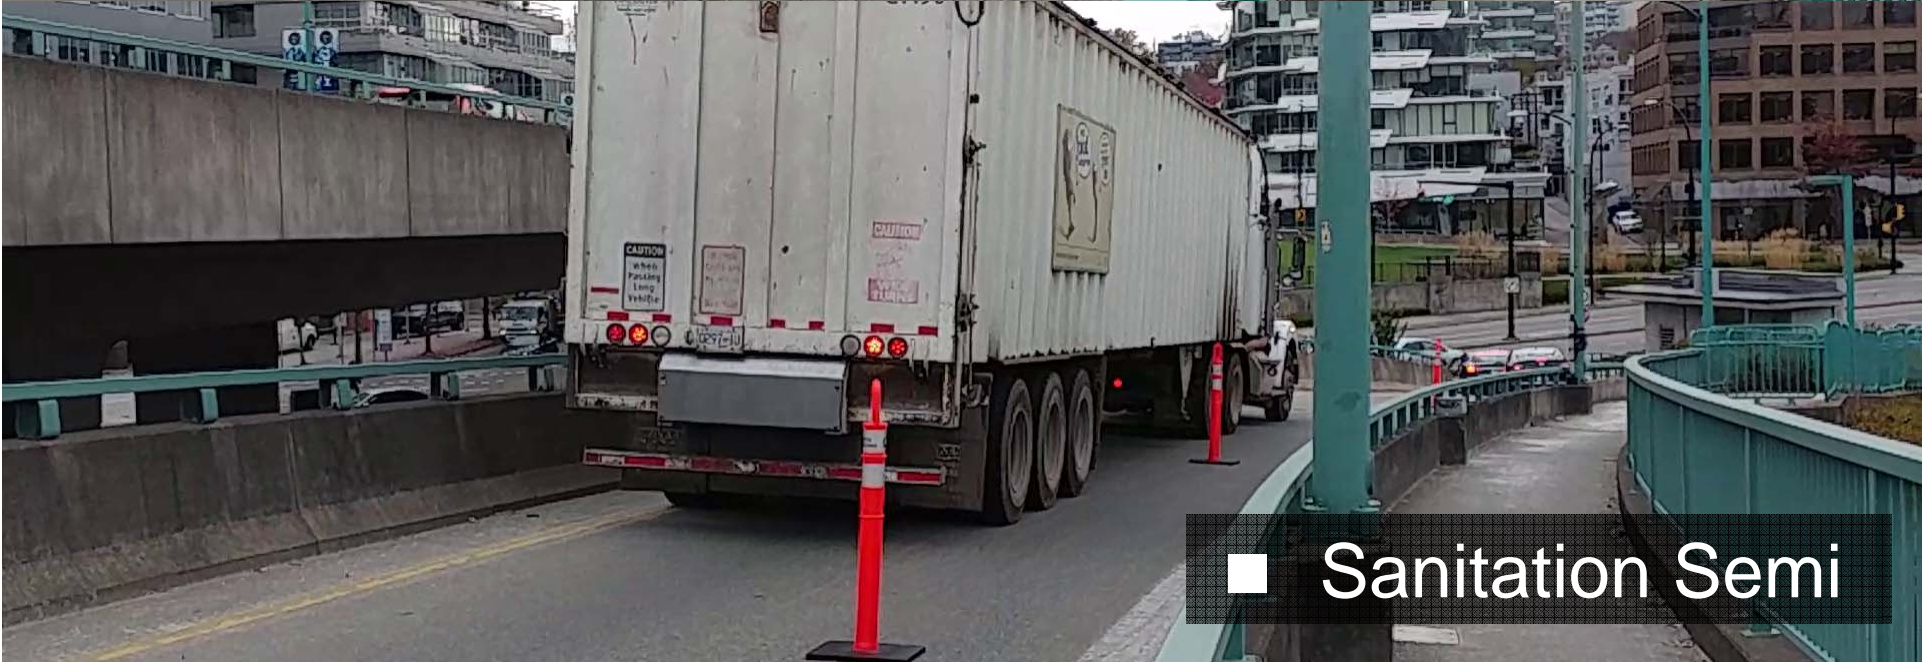
■ Sanitation Semi

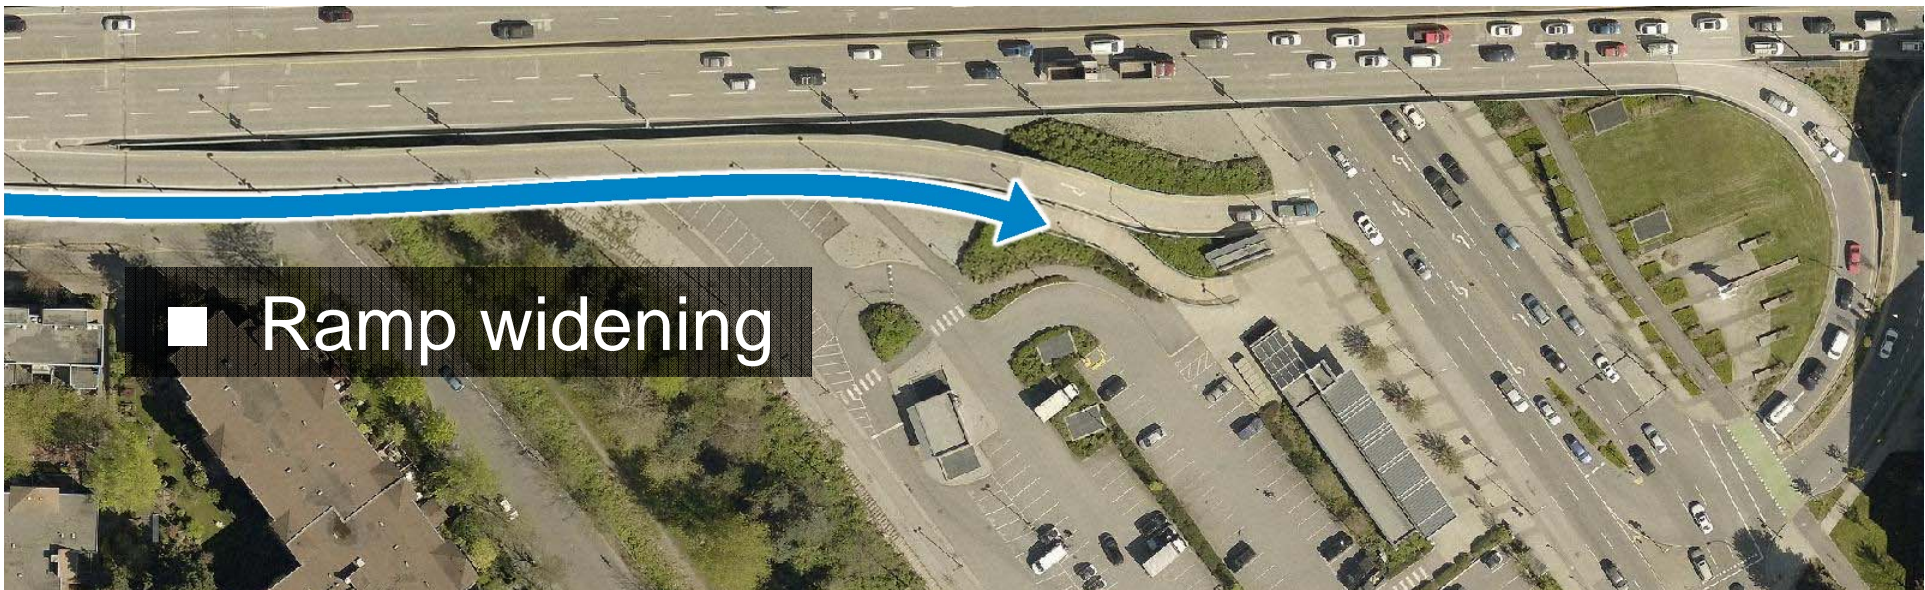
Design Refinements: Alternatives Explored

■ Ramp widening
