969 Burrard Street & 1019-1045 Nelson Street
STATEMENTS OF SIGNIFICANCE AND CHURCH CONSERVATION PLAN

1021-1023 NELSON STREET
STATEMENT OF SIGNIFICANCE
DECEMBER 2014

DONALD LUXTON
AND ASSOCIATES INC

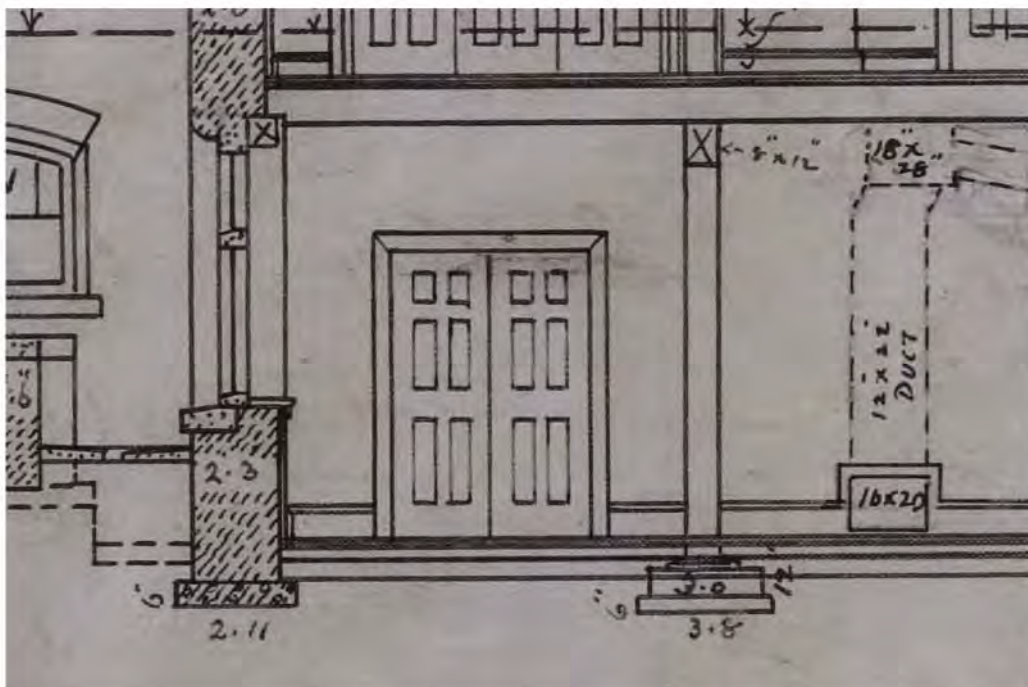
Foundation detail, Pinder Hall, 1909 [Burke, Horwood & White Architects]

The slab of the historic sanctuary consists of poured-in-place concrete though the thickness is not known. The plans of the School Building (Pinder Hall) indicate a 4" x 4" timber footing with 3" x 4" beams on top. The floor was finished with wooden planks. Historically timber footings were at times used for buildings of moderate height in order to provide for the necessary spreading of loads. As the lower level may have been structurally rehabilitated in the past, the current slab condition of the First Baptist Church should be assessed.

A structural condition assessment of the existing slab, including destructive testing where necessary, can be carried out without damaging character-defining elements. Rehabilitation work including structural and seismic upgrades should be designed in a manner that character-defining elements continue to be preserved.

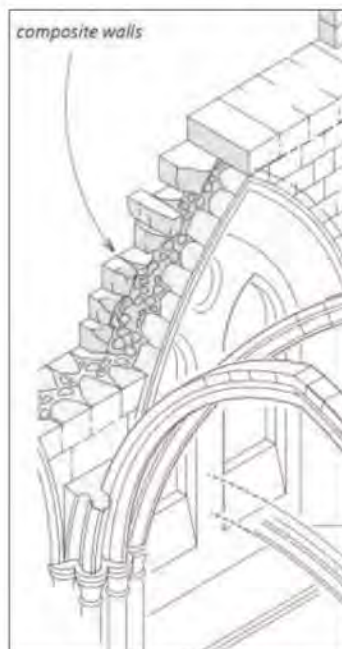
During the site review deteriorated joints were observed in few locations, particularly near the pavement where water back splash occurs. Here mortar was either porous or missing. Previous joint repairs above grade were

Left and centre: Examples of historic composite walls (www.buildingconservation.com); Right: Sandstone blocks at foundation

carried out, for example on the west façade facing the parking lot. These repairs were in some instances crudely done with high cementitious mortar of lighter colour and some efflorescence is presently visible on some of these joints. Additional joint repairs were undertaken on granite walls below the roofline, here with a darker mortar colour, and other locations.

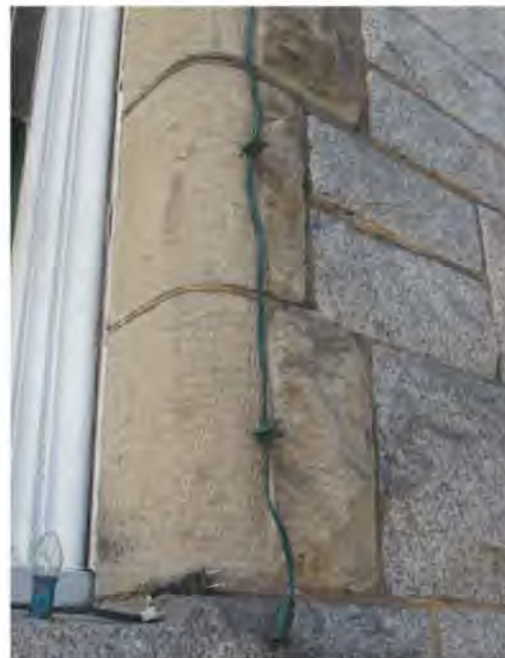
Sandstone window quoins

Sandstone lintels above main floor windows on the east façade of Pinder Hall show previous repair patches. The culprit of the sandstone damage cannot be conclusively determined. Based on the typical failure of sandstone it may be due to moisture damage. The repair patches are slightly darker than the original buff coloured sandstone and a white substance at the joints is visible, which may be efflorescence. Viewed from the sidewalk the surface finish of the repair patches appears to be slightly rougher than the original sandstone. Generally, the repair patches seem to be acceptable, but a closer condition assessment is recommended. Other inappropriate repairs of the original sandstone material were not noted. If replacement of original sandstone blocks is required in the future, the substitute stone should be of the same lithology as the original stone (replace in kind).

The exterior sandstone blocks are important character-defining elements of the First Baptist Church and will be retained. A close-up condition survey should be undertaken and, where required, restoration work will be carried out in accordance with national conservation guidelines.

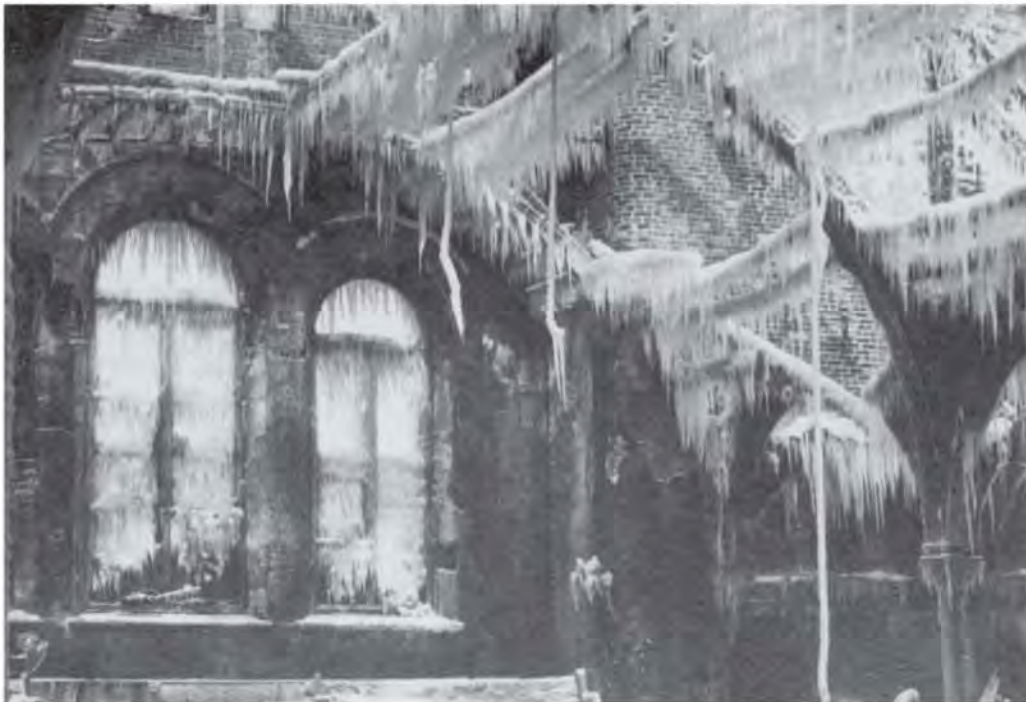
Interior of First Baptist Church (at Nelson Street and Burrard Street) after fire, 1931 [City of Vancouver Archives A71764]

Archival photos from the interior of the fire-damaged church reveal that bricks were also used for the construction of walls.

Further structural investigations should be carried out in order to determine the load-bearing wall assemblies of the First Baptist Church. All structural and/or seismic upgrades should be designed as not to diminish character-defining elements. Overall cleaning of the masonry walls should only be carried out if necessary and not be done with abrasive methods that may damage the face of the brick, sandstone or granite. In areas where masonry requires cleaning, use soft natural bristle brush and mild water rinse.

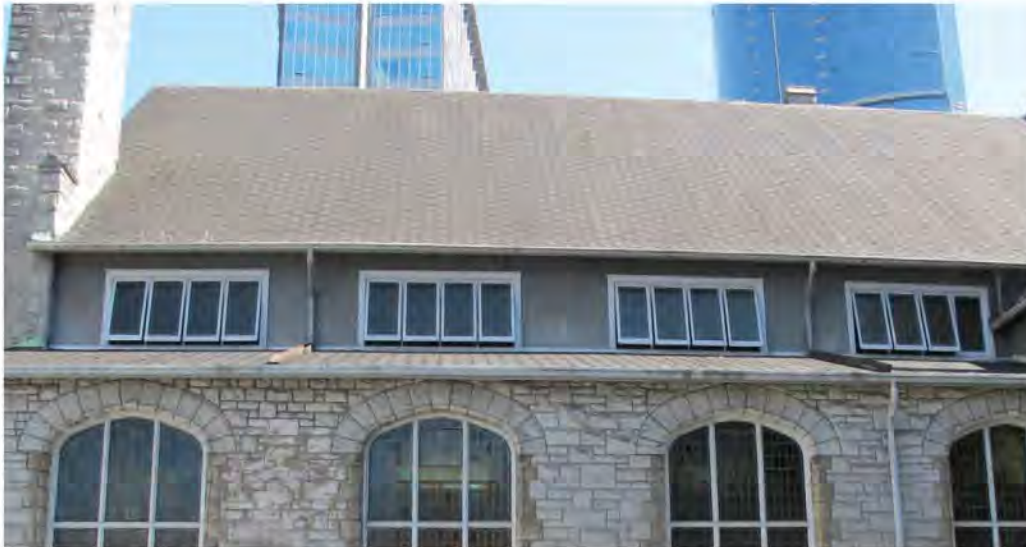
Pinder Hall looking north

viewed from the ground. On the west and north-facing clerestories minor delamination is visible at the bottom and near downspouts.

Particularly above the window bands on the west, east and south clerestories a white substance is staining the render that should be further investigated to determine the cause and extent of the condition. The staining could be caused by efflorescence, the deposit of soluble salt on the surface of the cementitious render characterized by a whitish haze indicating the presence of moisture. The grey colour of the current finish appears to be a later intervention and beside the condition of the render, its original paint colour should be investigated at Pinder Hall once access is available. The stuccoed wood-frame clerestory walls are important architectural elements of the building and should be restored.

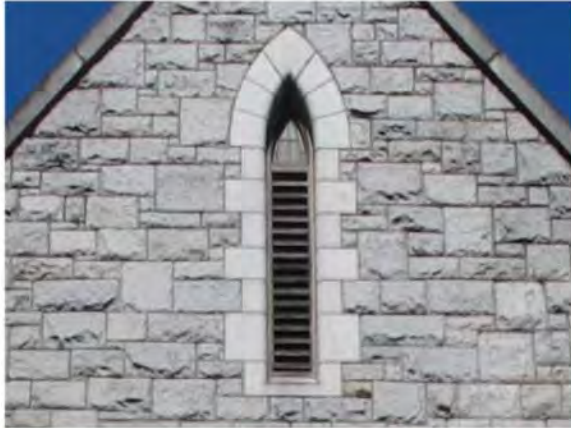
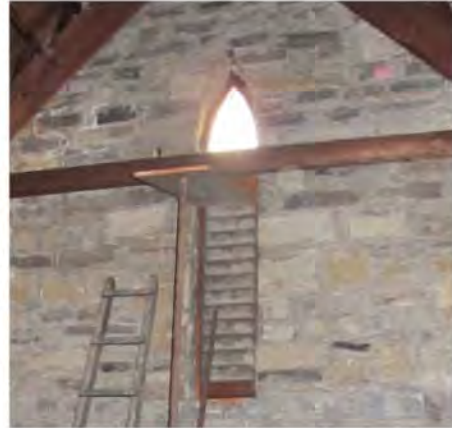
Image of Top Left: Close-up of the south façade louver; Top right: Interior view of the south façade louver; Bottom left: Louver detail, 1909 [Burke, Horwood & White Architects]; Bottom right: Anatomy of a Leaded Window [Preservation Brief 33: The Preservation and Repair of Historic Stained and Leaded Glass]

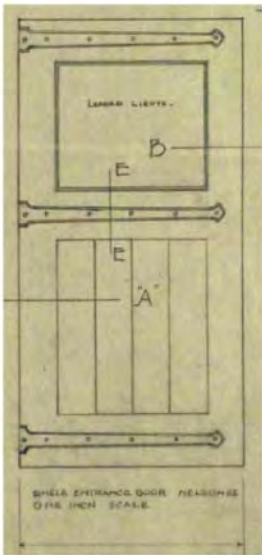
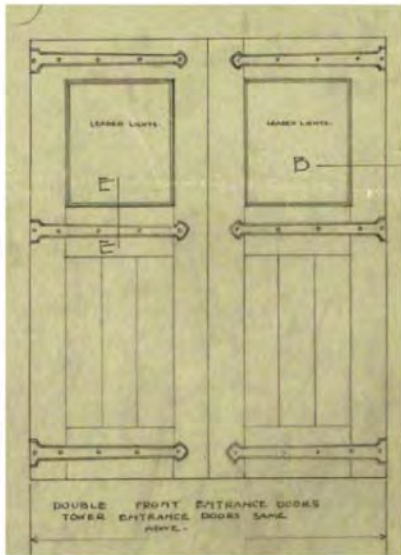
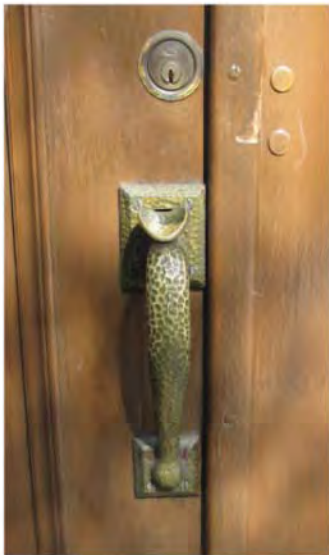
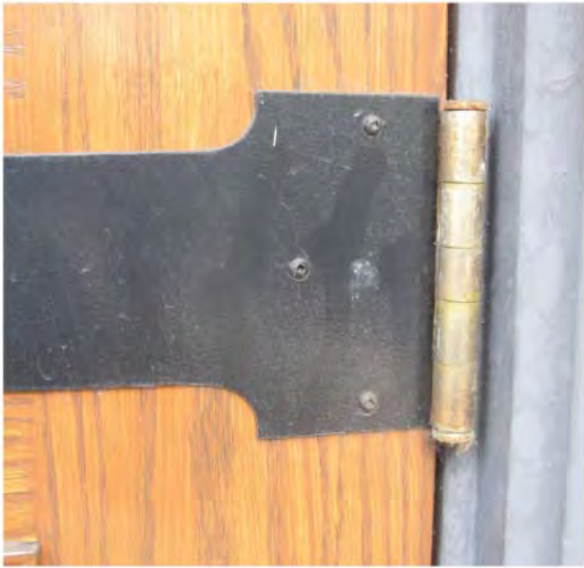
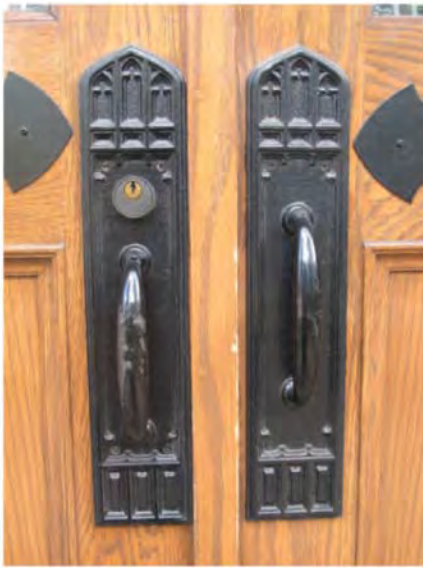
The original solid wood doors have leaded or wire woven glass, wooden panels and black iron strap hinges. The black strike plates of the main church bell tower are embellished and may not be original. Other door handles seem to have been replaced as well.

The wooden doors are generally in good condition except of signs of weathering notable at the bottom where paint is deteriorating and bare wood exposed to the elements. The wood doors and associated features are significant character-defining elements and will be retained in their original locations and restored as necessary.

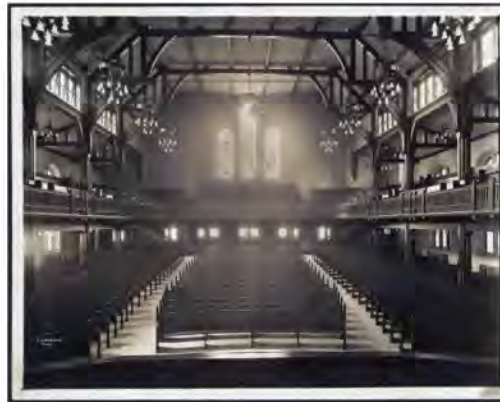
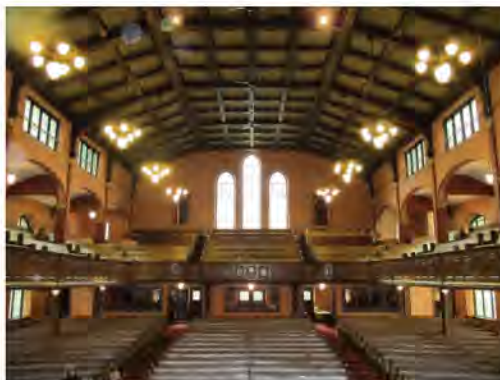
The main church was gutted by fire on February 10, 1931, which led to severe damage of the roof, timber support structure and interior wooden elements including furnishings. The reconstruction was overseen by Charles Bentall and the Dominion Construction Company and completed early November 1931. Since then the interior of the main church has remained mostly unchanged.

Top left: Interior before 1931 fire [Horwood Collection, Archives of Ontario]
Bottom left: Current condition of post-fire reconstruction

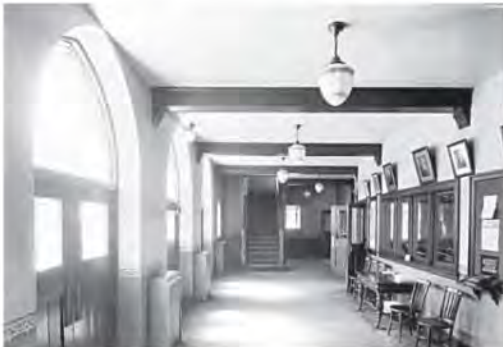
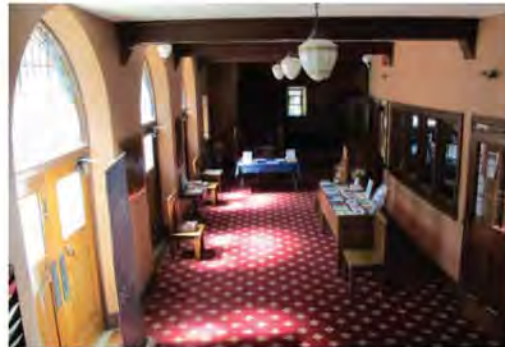
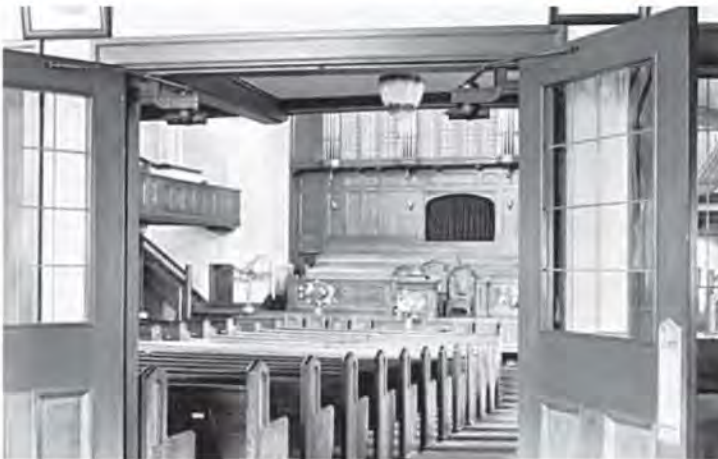
Top left: Narthex with south entrance doors and staircase to balcony after fire in 1931 [Vancouver Public Library 8105B]; Top right: Narthex as it appears today; Bottom: View from narthex into nave after fire in 1931 [Vancouver Public Library 8105]

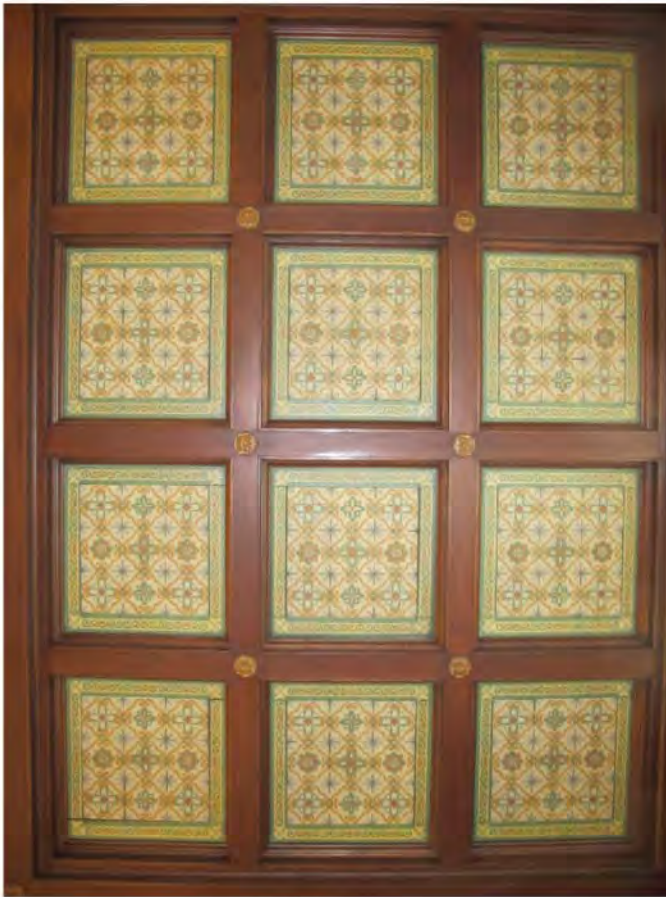
Coffered ceiling in sanctuary

The original hammerbeam truss system was destroyed in the 1931 fire. The reconstructed segmental-arch ceiling features a wooden coffered ceiling with corbelled roof supports. The timber beams seem are clad in dark-stained wood, and painted corner rosettes embellish the ceiling. Dark-stained wooden mouldings surround the decoratively painted acoustic tiles with green and beige patterns.

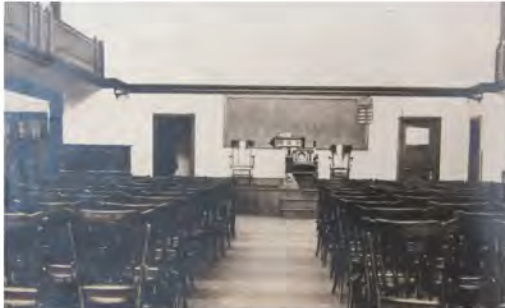
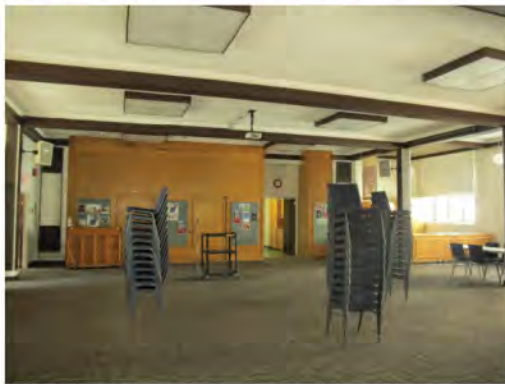
The lecture hall in the School Building was designed originally as a double-height volume. In 1977, the hall was broken into two separate floors through the insertion of a floor system that replaced the balconies. This later intervention should be removed to reinstate the original volume.

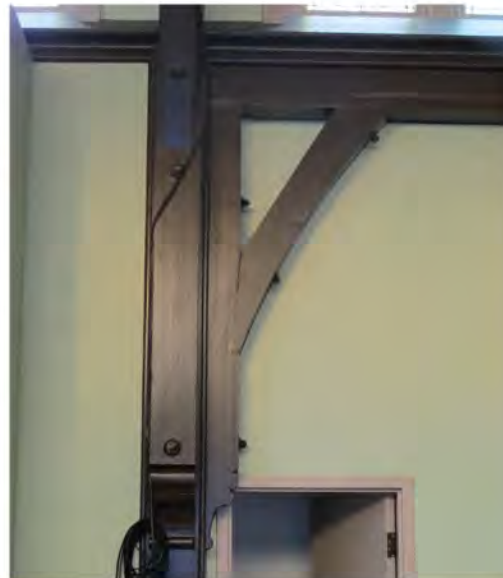
Structural timber

The heavy timber structure of Pinder Hall includes a hammerbeam roof truss, an open timber roof truss system typical for medieval Gothic architecture and reused in Gothic Revival style buildings. Dark-stained fir columns and beams, wall posts, and braces still exist within the renovated space, and can be retained.

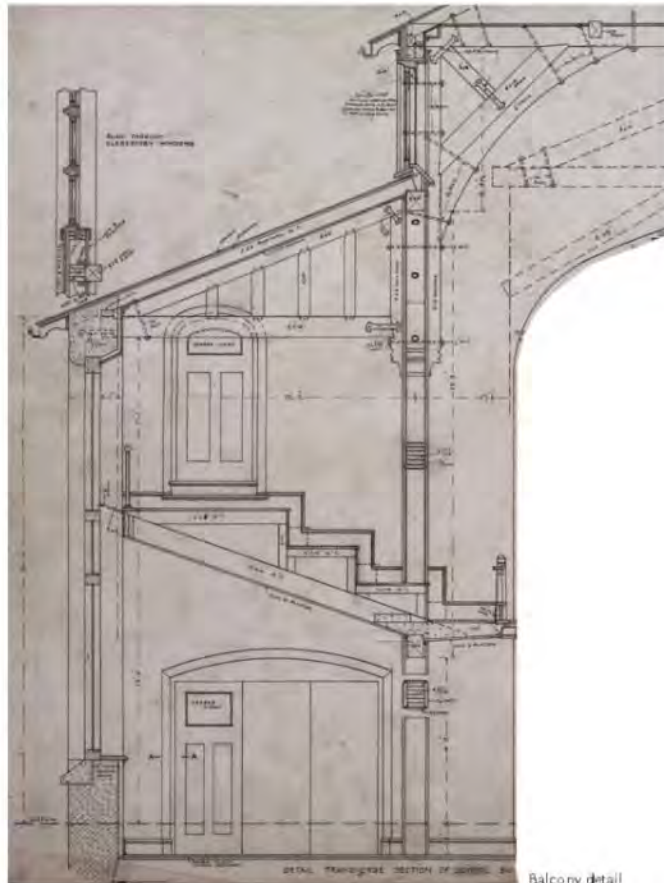
Balcony detail

Raked balconies were originally located on the north, south and east sides of the hall. It is unknown to what extent the original structure was disturbed during the 1977 renovations; further site investigation is recommended to determine the condition and extent of any original framing materials.
