## COUNCIL REPORT

SUBJECT: Heritage Incentive Program (HIP) 2024 Update and Grant Recommendation for 355 Burrard Street (Marine Building)

355 BURRARD STREET, VANCOUVER, BC

## FACADE CONSERVATION PLAN

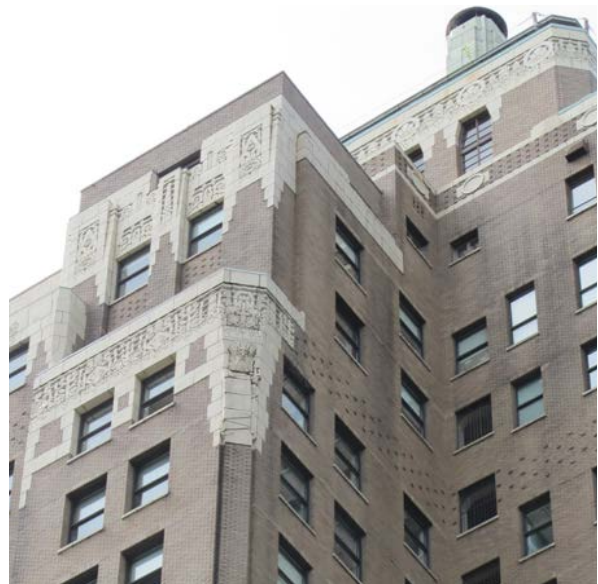
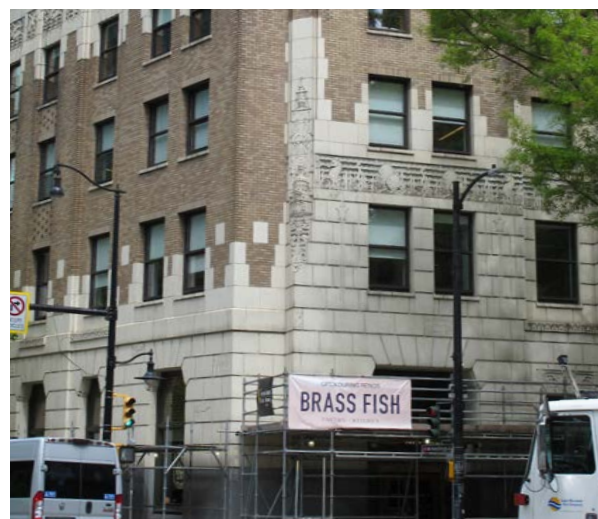
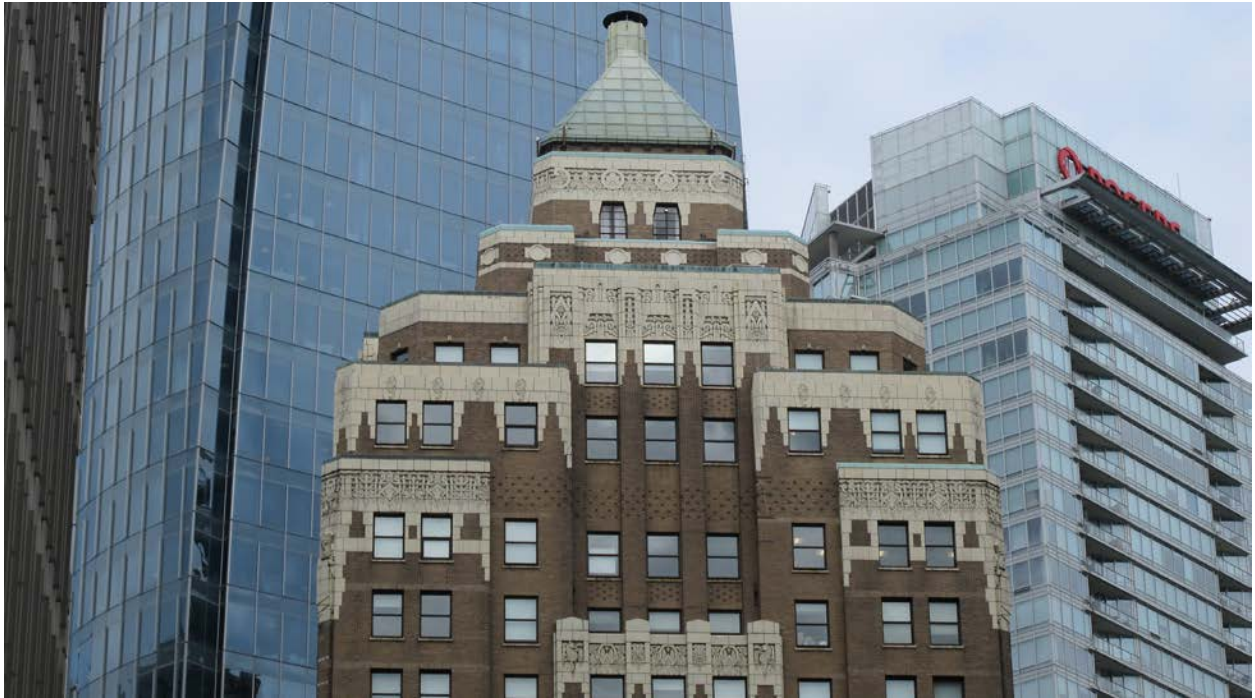
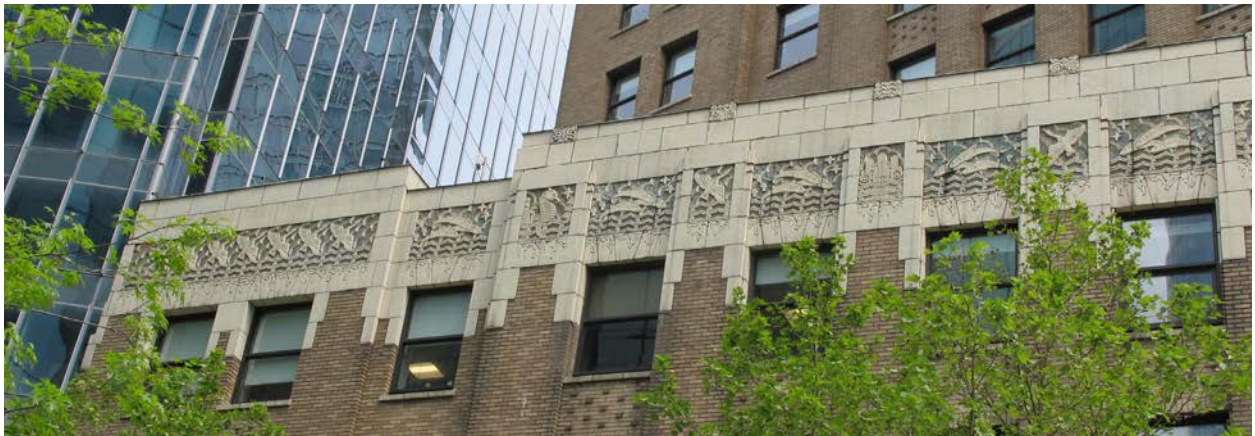
At the upper floors of the building's central stepped tower and north and south wings, terra cotta of floral, marine, and transportation themes is used to contrast the building's brick exterior. Terra cotta is used at the parapets, window sills, balconies, panels, friezes, and roof tiles. The terra cotta used consists of plain panels as well as decorative panels, similar to the those of the lower floors of the West Hastings and Burrard Street facades. The terra cotta on the exterior of the building is original and overall appears to be in good condition, based on review from street level. There is evidence of deterioration present such as discolouration, staining,

cracks, chips, spalled areas exposing the biscuit, and past unsympathetic repairs. The nature and condition of the anchoring of the terra cotta to the back up structure is unknown.

The focus of the proposed interventions to the identified scope areas (see RJC drawings R.301 and R.302 dated 2024-08-09) for the building's terra cotta include: anchoring of the terra cotta; repair of cracked and damaged units; cleaning; and localized repointing. Terra cotta clad parapets and balconies will also be restrained.

- Retain the original glazed terra cotta of the exterior of the Marine Building.
- Anchor terra cotta in identified work areas. Anchor through mortar joints to minimize impact to terra cotta.
- Repair cracked and damaged terra cotta. Where repair mortars are used, ensure mortar is suitable for use with historic terra cotta. Repaired appearance to match appearance and finish of original unrepaired terra cotta.

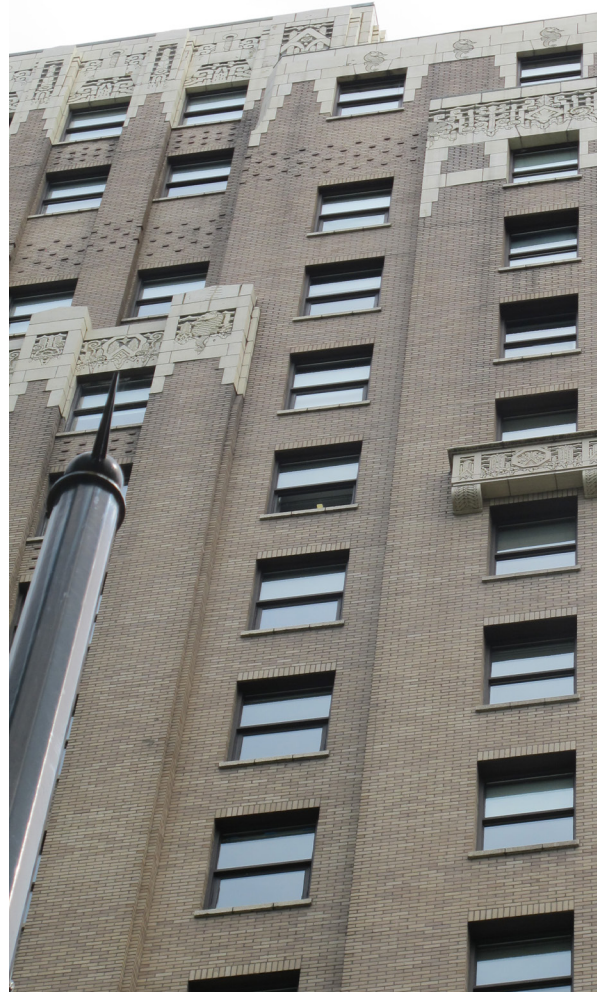
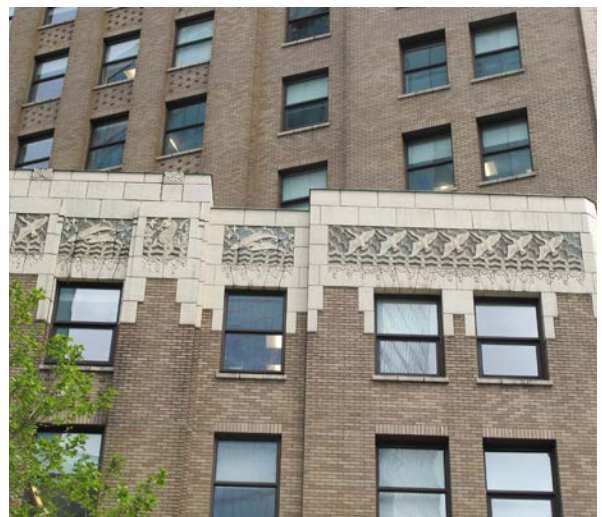
All exterior facades of the Marine Building are clad in a variegated brown brick laid in running bond with light coloured recessed mortar. Soldier course brick window lintels and brick panels with relief pattern of header bricks accent each of the facades. The brick is original to the time of the building's construction and overall is in good condition. However, areas of deterioration are present in the form of discolouration and staining, cracked bricks, spalled bricks, mortar loss, past repairs, and repointing. Previous work on the brick exterior of the Marine Building has been carried out as part of an ongoing maintenance program. The work completed included replacement of deteriorated brick present at slab edges, sills, lintels, and returns of the building.

More recently, following the explosion of BC Hydro's vault in front of the Burrard Street facade in February 2023, a review of sections of Burrard Street from scaffolding was undertaken. During this review, significant cracks were identified. Exploratory work to determine the cause of the masonry deterioration was carried out and reviewed by RJC. The exploratory work consisted of the removal of the exterior brick veneer to determine the manner of brick anchoring and its condition, as well as identify any other causes which may be contributing to the brick's deterioration. Review of available archival drawings show the brick veneer sitting on shelf angles at slab edge.

The exploratory work determined steel shelf angles supported the exterior wythe of brick. The condition of the shelf angles varied with some exhibiting severe corrosion resulting in 'rust jacking' contributing to the deterioration of the exterior brick. The exploratory investigations also determined that the original steel
