ADMINISTRATIVE REPORT

TO: Standing Committee on City Finance and Services
FROM: General Manager of Planning and Development Services
SUBJECT: 320 Abbott Street - Façade Grant - DE 416539

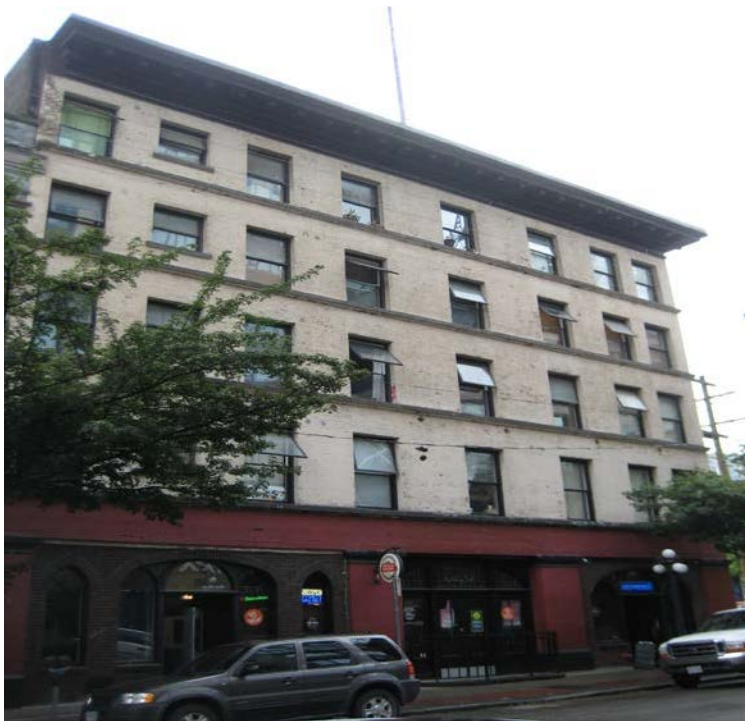
320 Abbott Street (Hotel Metropole) -Existing Condition

The Hotel Metropole is a five-storey masonry commercial building occupying part of the east side of the 300 block of Abbott Street, with a secondary frontage on the mid-block alley, in the historic Gastown district. It is distinctive for its two formal facades, on Abbott Street and the alley, and a prominent projecting cornice. The current uses are commercial, on the ground floor, and the hotel/rental accommodation (Single Room Accommodation) on the upper floors. The Hotel Metropole is a municipally designated heritage site and it is listed in the category “C” on the Vancouver Heritage Register.

The original 1910 central hotel entrance and flanking storefronts on the principal façade were removed in 1930s and the current assembly has remnants of the 1930s storefront. The 1930s alterations are an interesting part of the evolution of the building and thus worthy of preserving.
